51 SHADES

Valuation & Condition Survey
Hong Kong
16 December 2014 & 21 January 2015

51 SHADES is a GRP, twin screw, motor yacht.

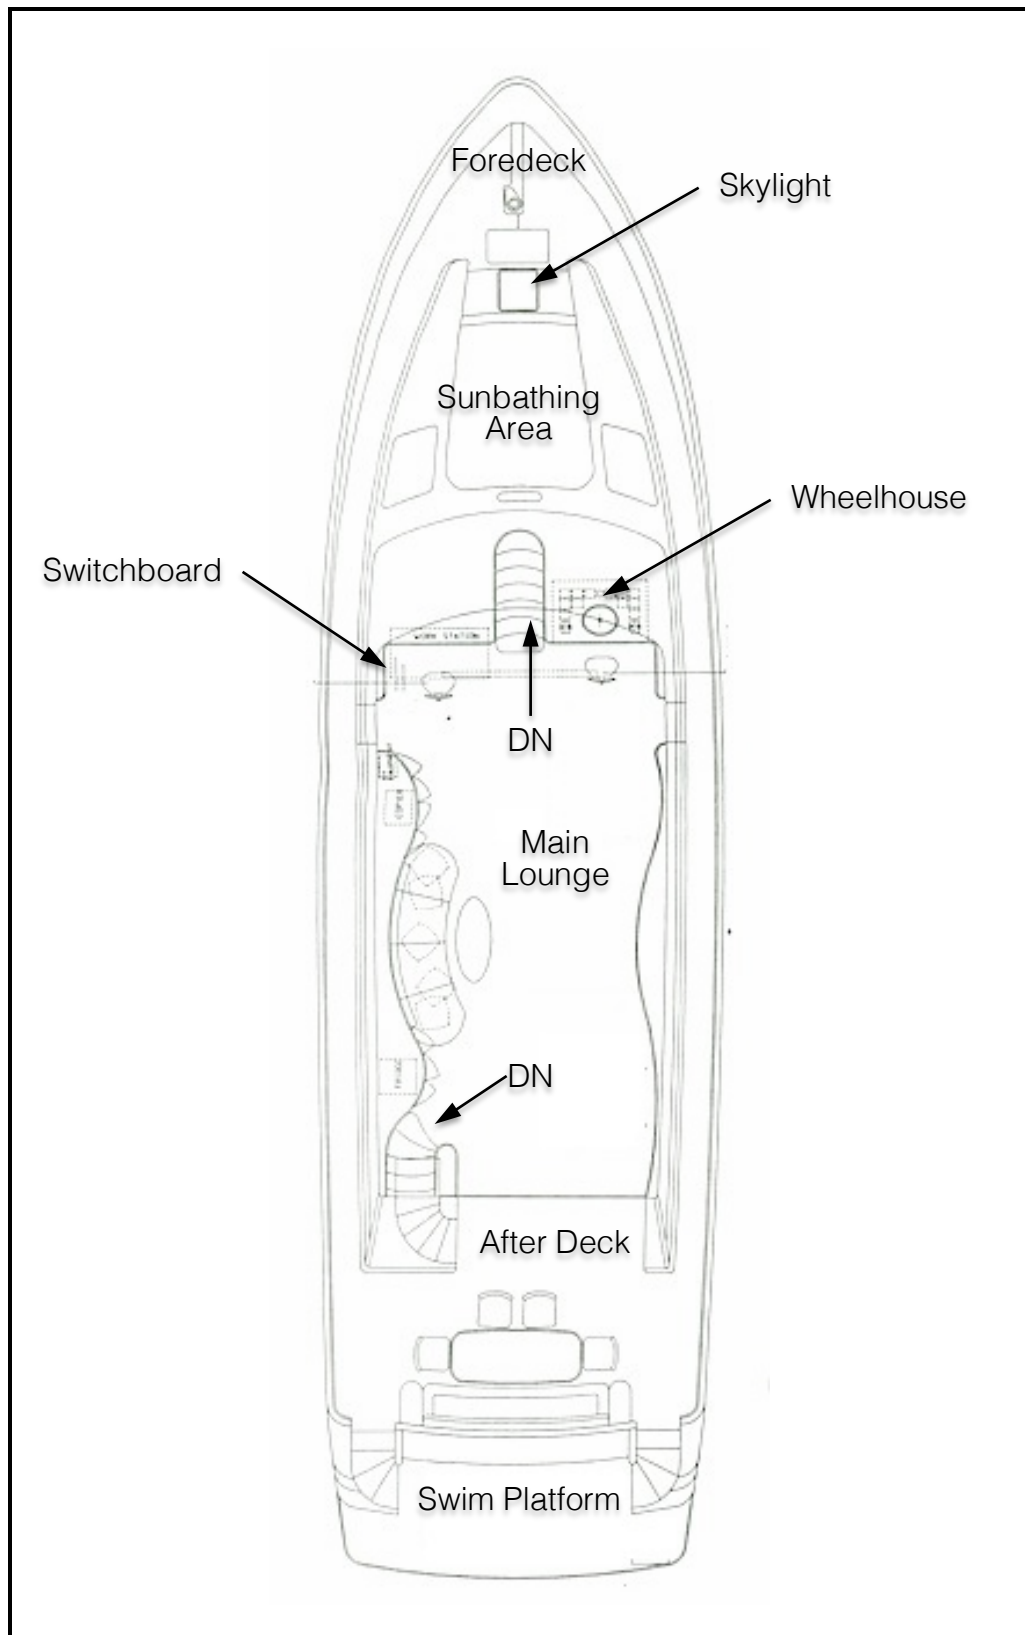
Figure 1. General Arrangement of Main Deck.

MAIN DECK		
1.	Layout: (See Figure 1)	The main lounge takes up the central part of the vessel, the engine room is being below the main lounge. Access to the foredeck is via a narrow deck on either side of the superstructure. At the after end of the main deck is a teak-laid GRP after deck and a small transom deck. The main lounge is fitted with lockers and sofas either side. Cockpit area with the steering console fitted with navigational instruments on the starboard side forward. Staircases lead from the centre forward end of the cockpit area and port after end of the main lounge down to the lower deck. Vertical staircase with wooden steps leads from the port forward end of the after deck up to the flybridge. Bench seat at the after end of the after deck.

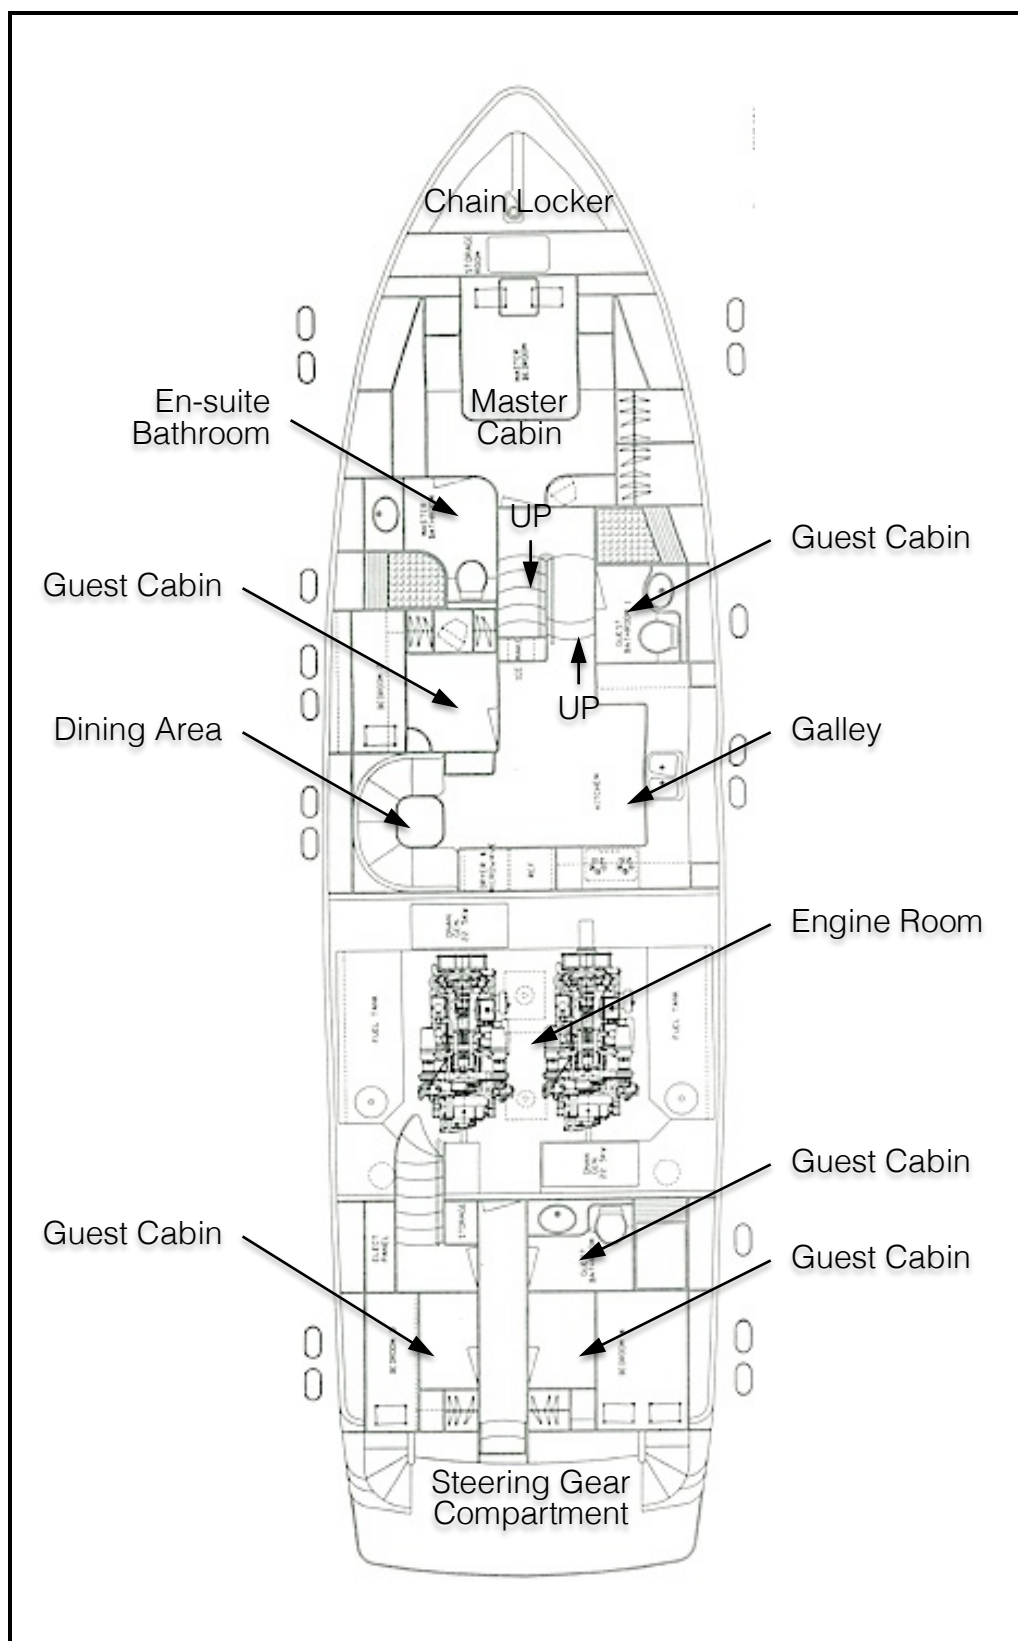
Figure 2. General Arrangement of Lower Deck.

LOWER DECK		
1.	Layout: (See Figure 2)	At the forward end of the lower deck is a master cabin fitted with a queen sized bed, wardrobe and en-suite bathroom. On the port side is a dining area, and guest cabin fitted with two single bunk and wardrobe. Guest bathroom and galley situated on the starboard side. At the centre lower deck is the engine room. Aft of the engine room is a guest quarter. On the port side is a guest cabin fitted with two double bunks and wardrobe. On the starboard side is a guest bathroom, and a guest cabin fitted with a double bed and wardrobe. The steering gear compartment is situated at the after end of the guest quarter. Access to the engine room is through a door at the forward end of the guest quarter.

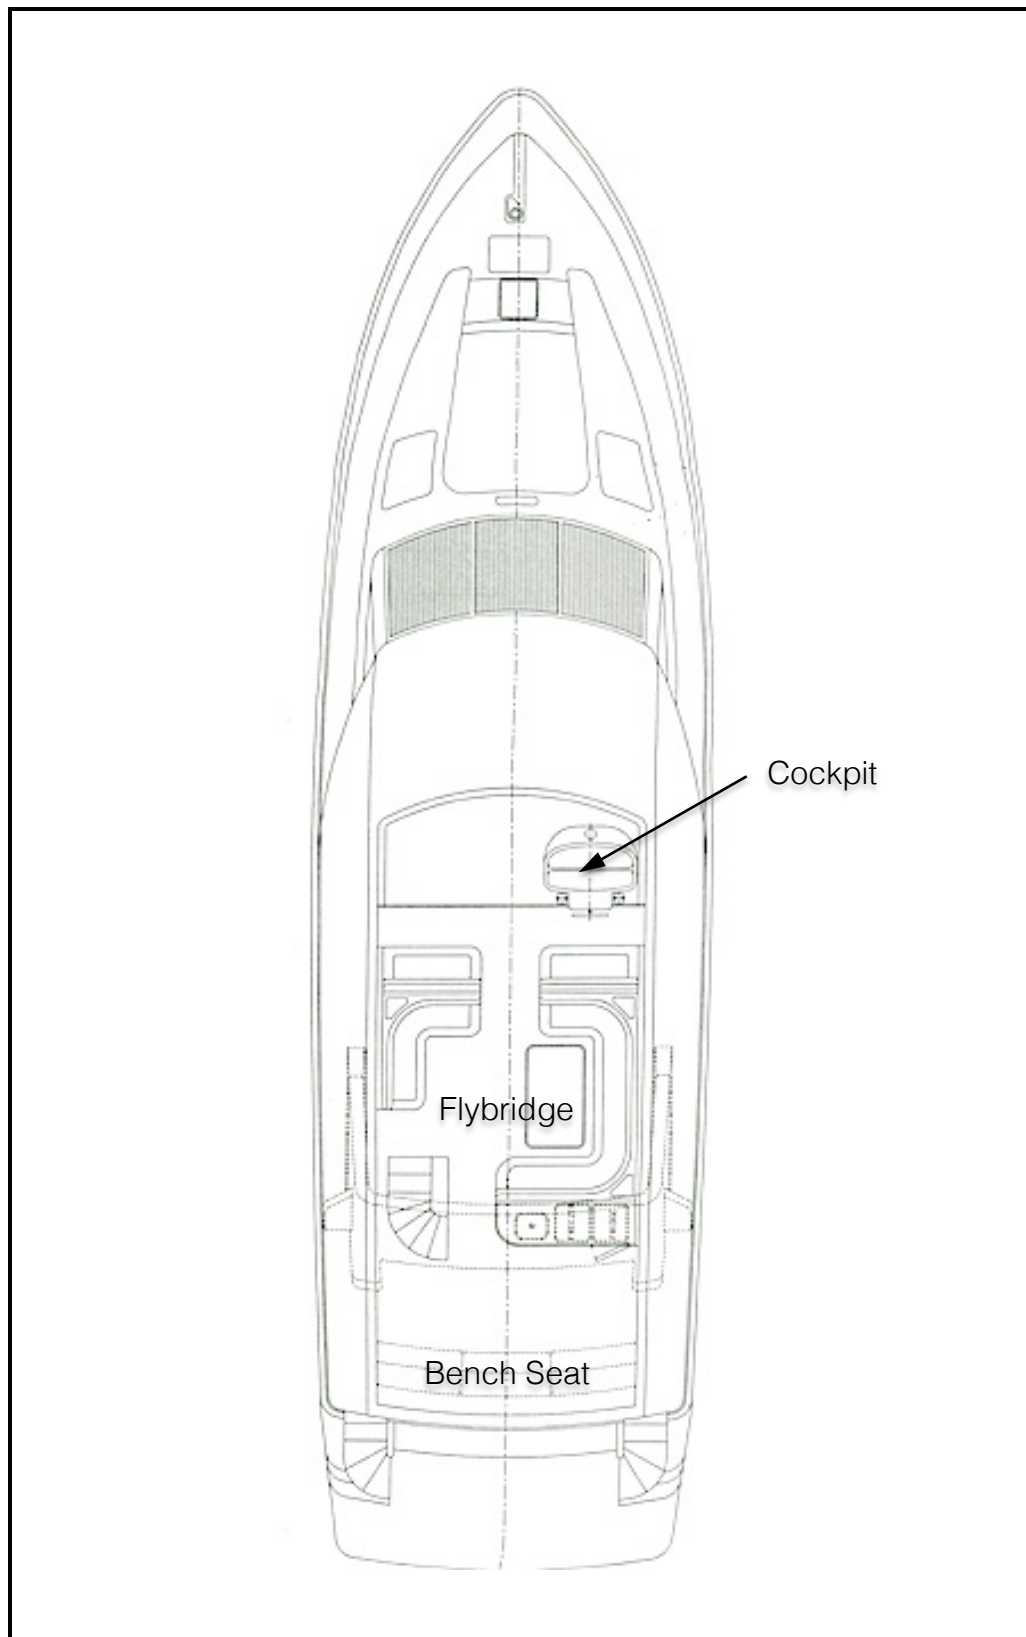
Figure 3. General Arrangement of Flybridge Deck.

FLYBRIDGE		
1.	Layout: (See Figure 3)	Open deck with bench seat on the port side and after end. White GRP table and wrap around seat situated on the starboard side. Double helm seat and engine console at starboard forward end together with navigational equipment. Radar arch at the after end. Spiral staircase leads from the port side down to the after deck.

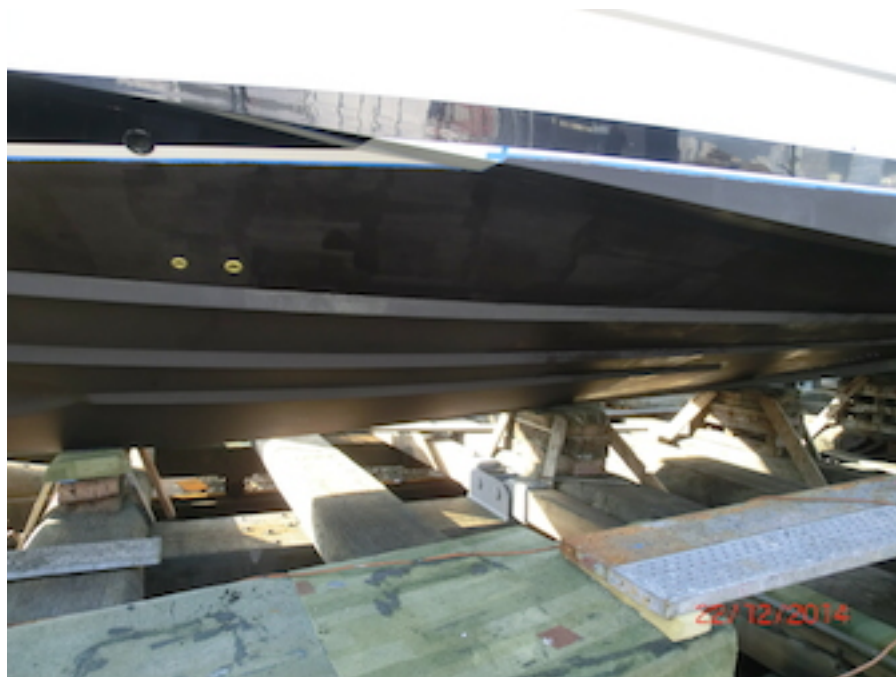
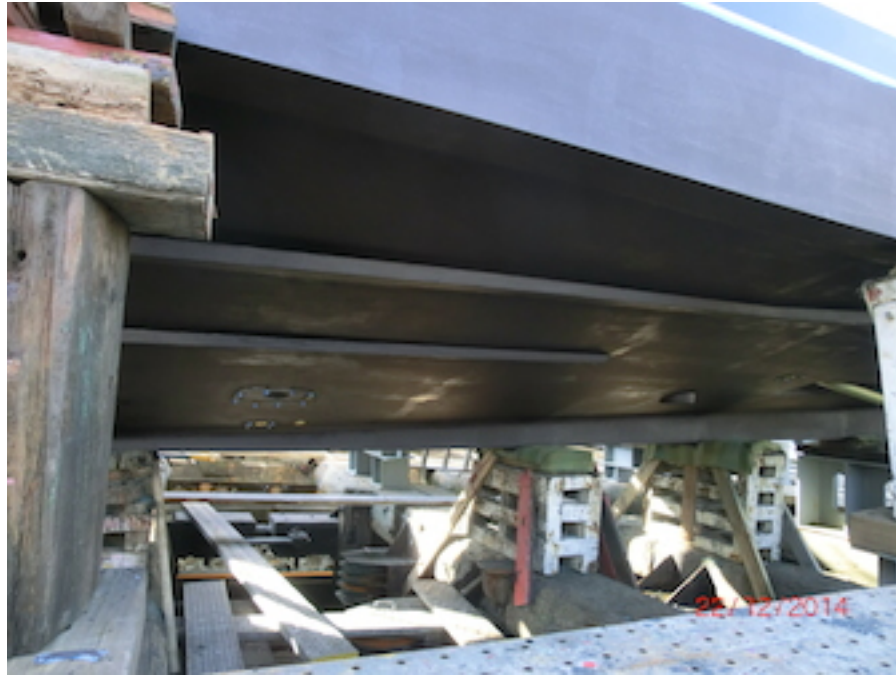
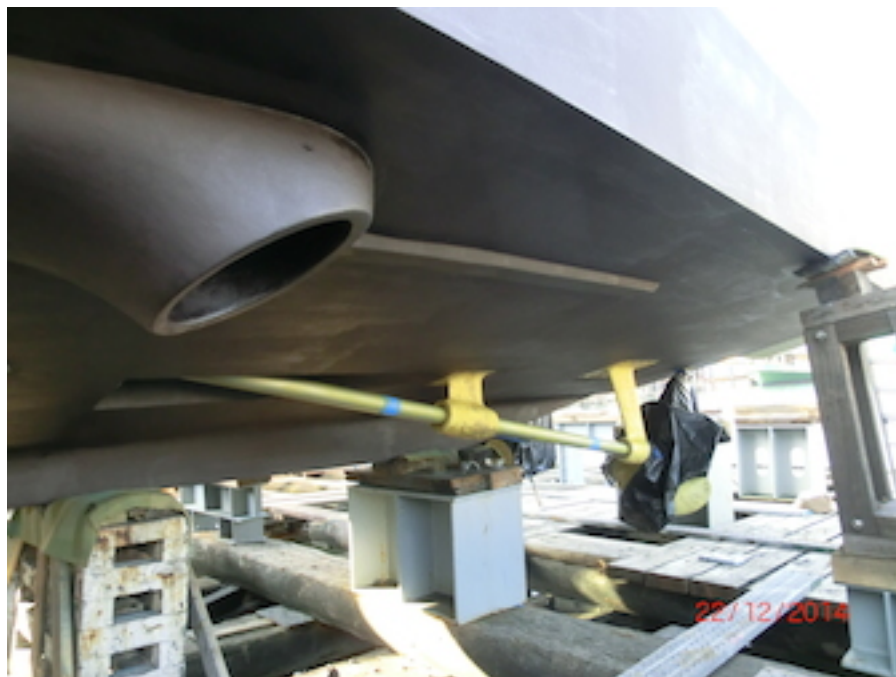
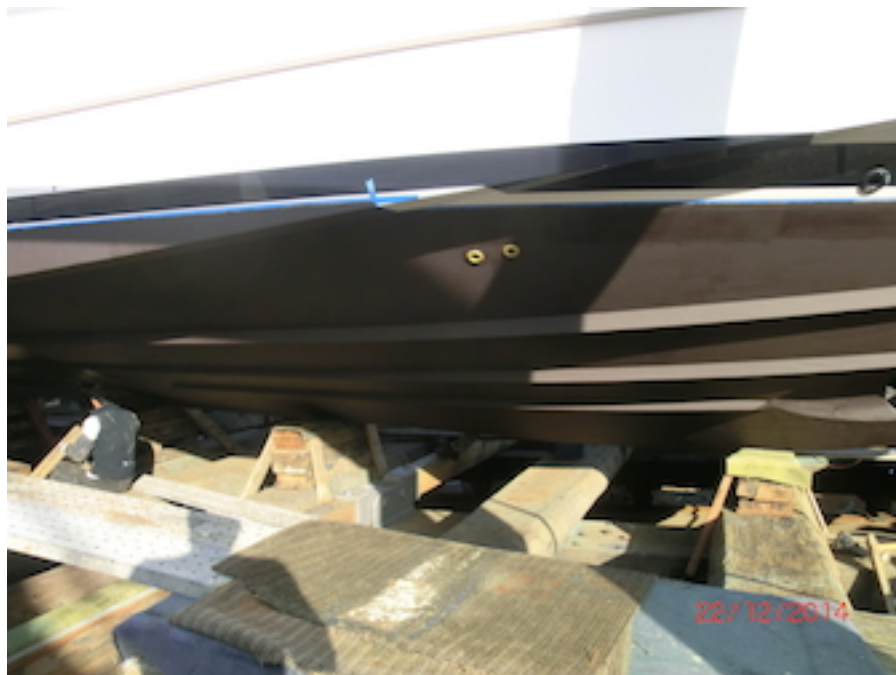
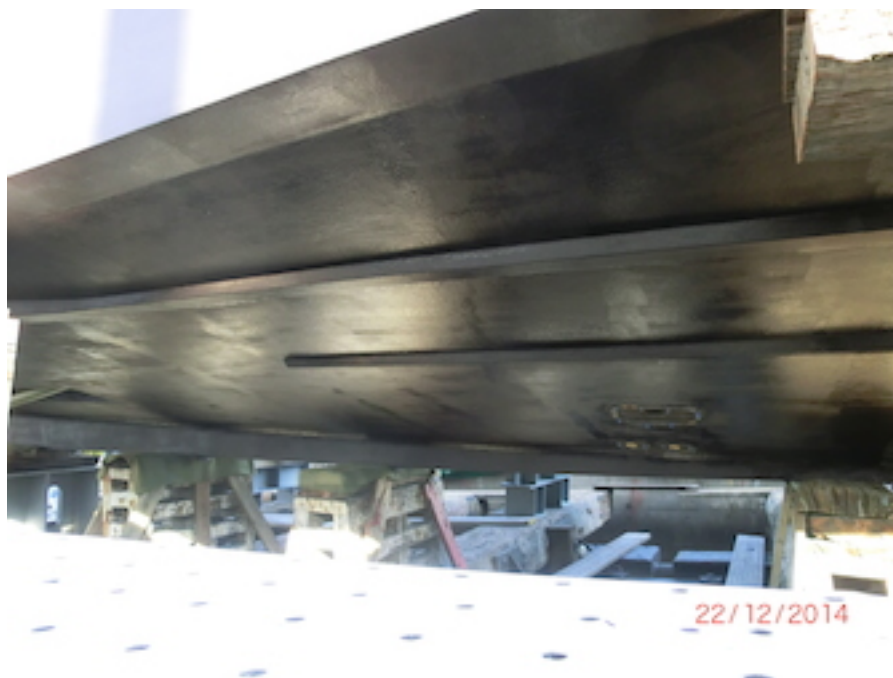
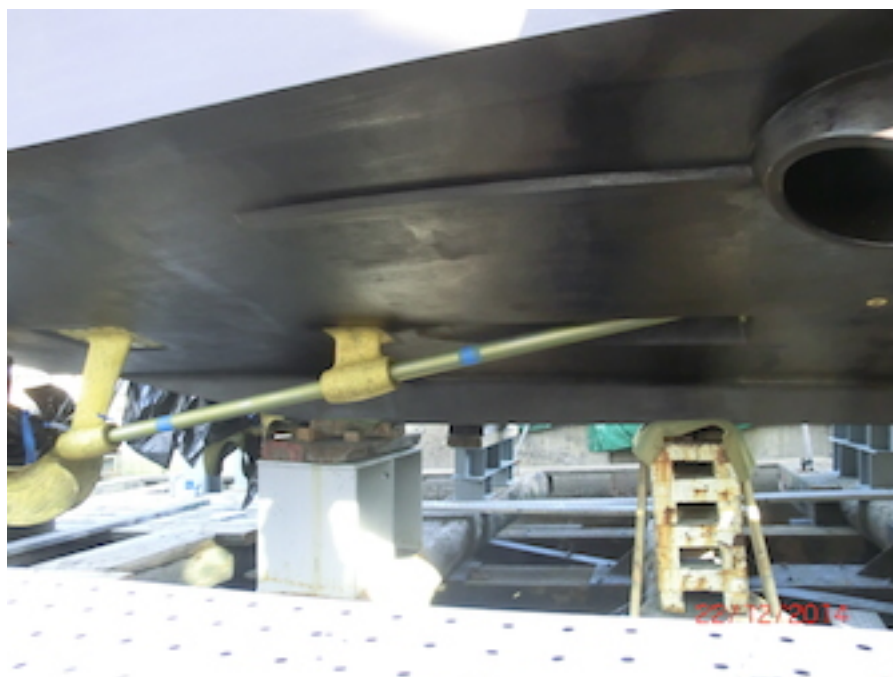
CONDITION OF HULL		
1.	External Hull:	GRP construction. The underwater external hull was inspected on the slipway. Anti fouling found in good condition. Moisture content readings were taken over a 48 hours period using the Tramex Skipper Plus moisture content meter and found low. Antifoul system is fitted internally. The above water external hull in white painted GRP construction. Good.

Our survey took place on 16 December 2014 & 21 January 2015, whilst the vessel was on the slipway at Tsing Yi North Coast Yacht Services Ltd, Lot 11 Tam Kon Shan Road, Tsing Yi, New Territories, Hong Kong and during a short sea trial, for the purpose of carrying out a valuation condition survey. The underwater area was inspected on the slipway. Moisture content readings were taken 48 hours after the vessel had been hauled out of the water and found dry. The underwater area was being striped to gelcoat surface, dried out, coated with three layers of epoxy primer and two layers of anti fouling. Anti fouling found in good condition. There were no visible signs of hull deterioration or onset of osmosis.

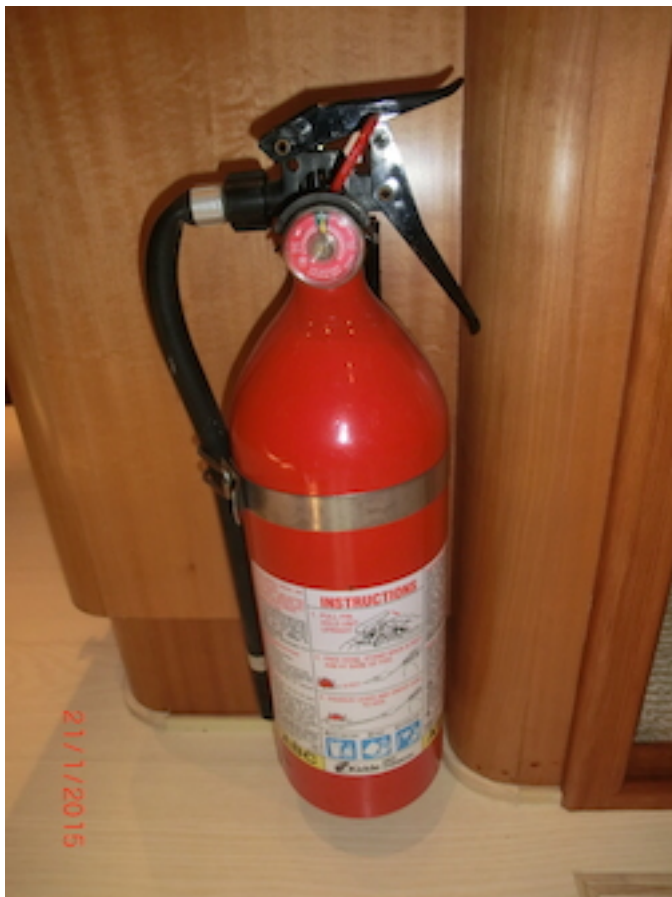
Photograph 28

We sighted the fire fighting and mooring equipment where possible. Additional fire extinguishers are required on board to comply the Hong Kong Marine Department Safety Standard.

View of portable dry chemical fire extinguisher.

1. Existing portable fire extinguishers to be replaced with two 4.5 kg portable dry powder fire extinguishers.
2. Engine room fire extinguishing system is due for annual inspection.
3. Two N.U.C. lights to be fitted on board.
4. The name or certificate of ownership number of the vessel to be marked on the lifebuoys.
5. Main fire pump to be fitted on board. The pump and its sea suction should be situated outside the engine room.

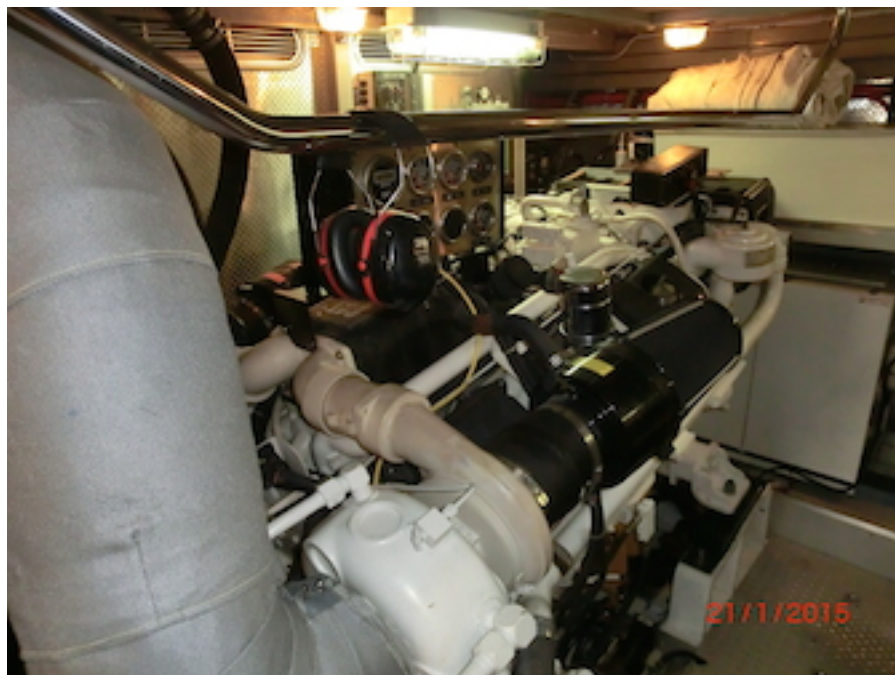
Photograph 46

The main engines were tested at full throttle 2,300 rpm giving a speed of approx. 26.0 knots and astern under load during the short sea trial. Both main engines found to be in good working order. All engine instruments were also tested and found in good working orders. The engine hour display found to be 740.3 port and 750.2 starboard after the sea trial.

View of port main engine.

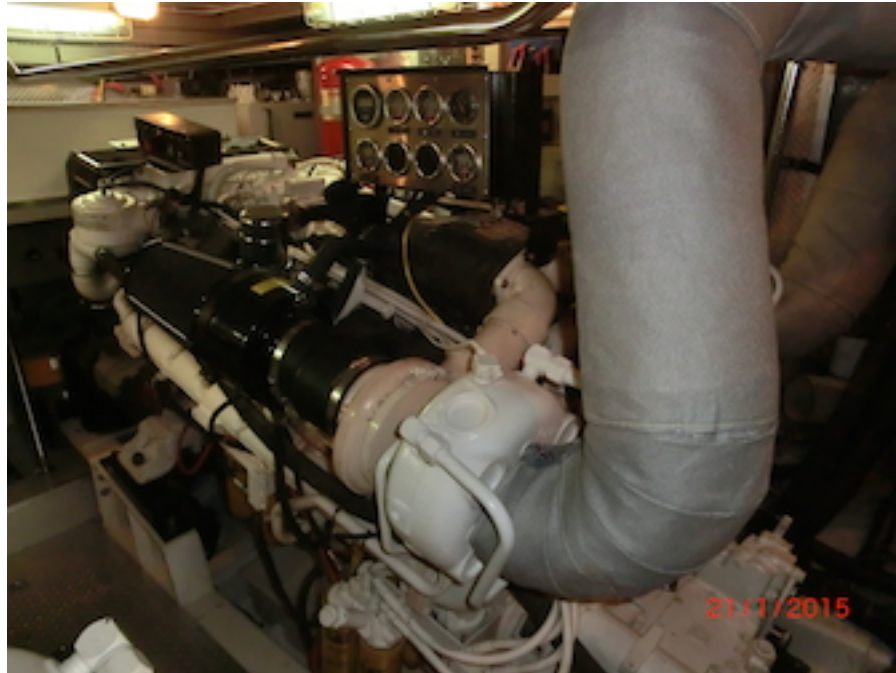
Photograph 47

View of starboard main engine.

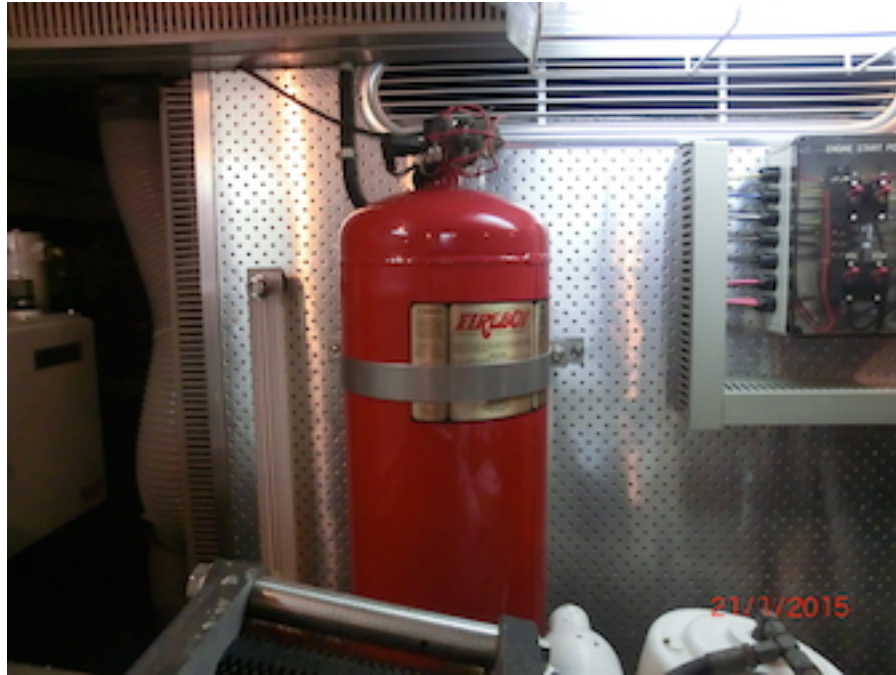
Photograph 55

View of automatically triggered fire extinguishing system.
