51 SHADES

Valuation & Condition Survey
Hong Kong
16 December 2014 & 21 January 2015

51 SHADES is a GRP, twin screw, motor yacht.

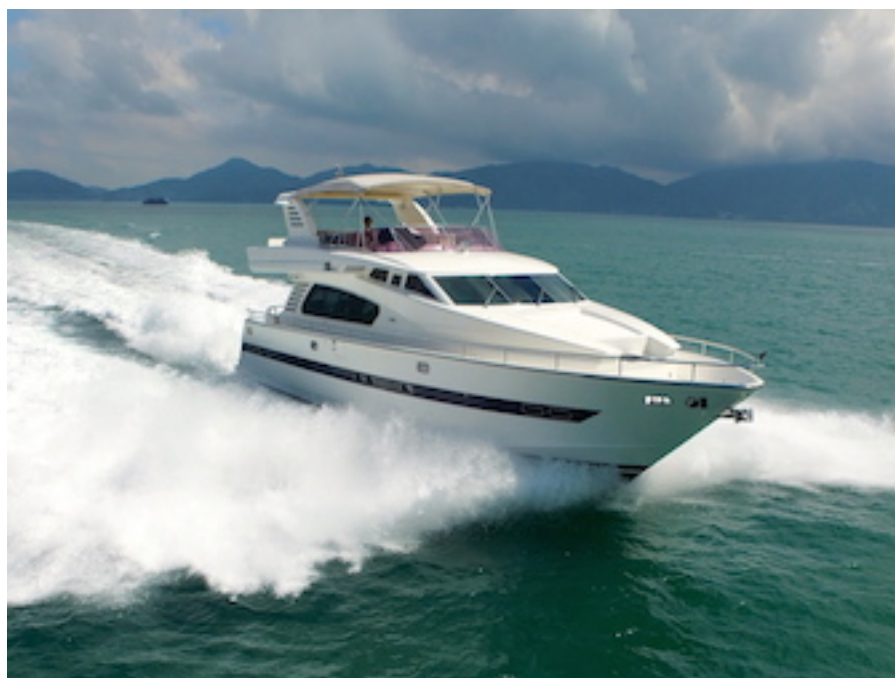
Photograph 1

General view of vessel.

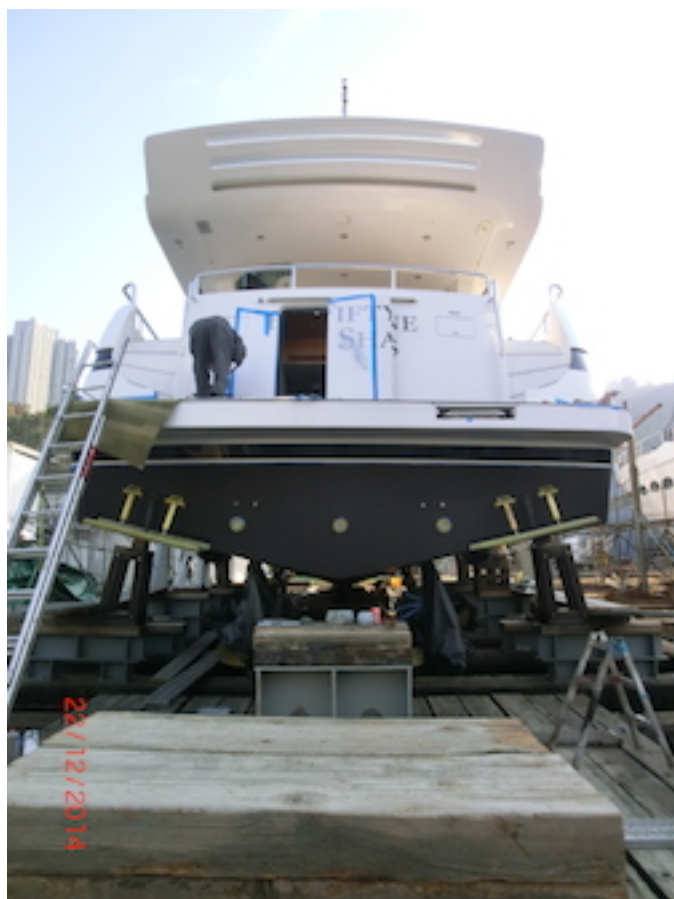
Photograph 2

View of stern.

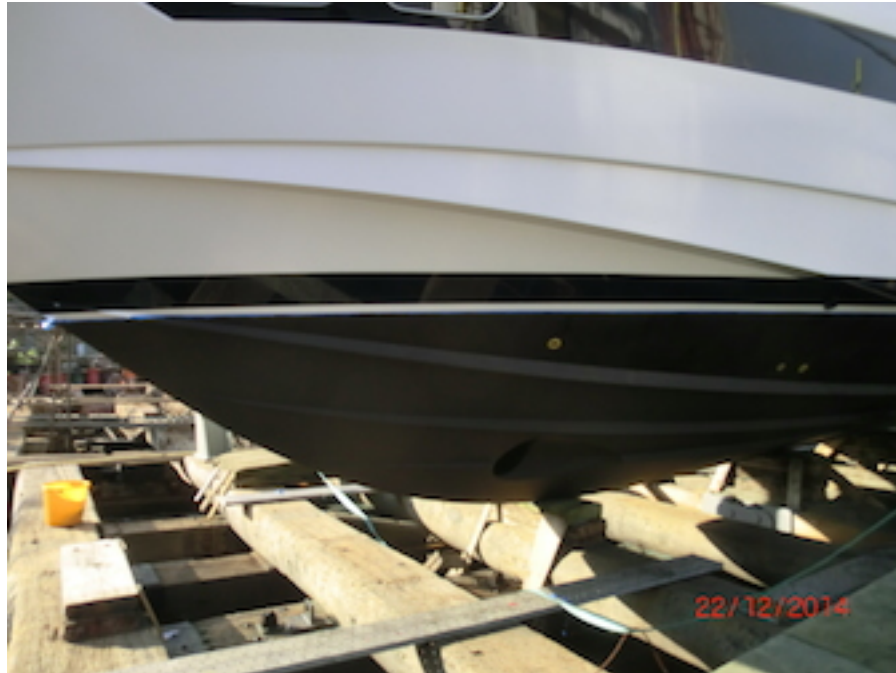
Photograph 3

View of port side bow.

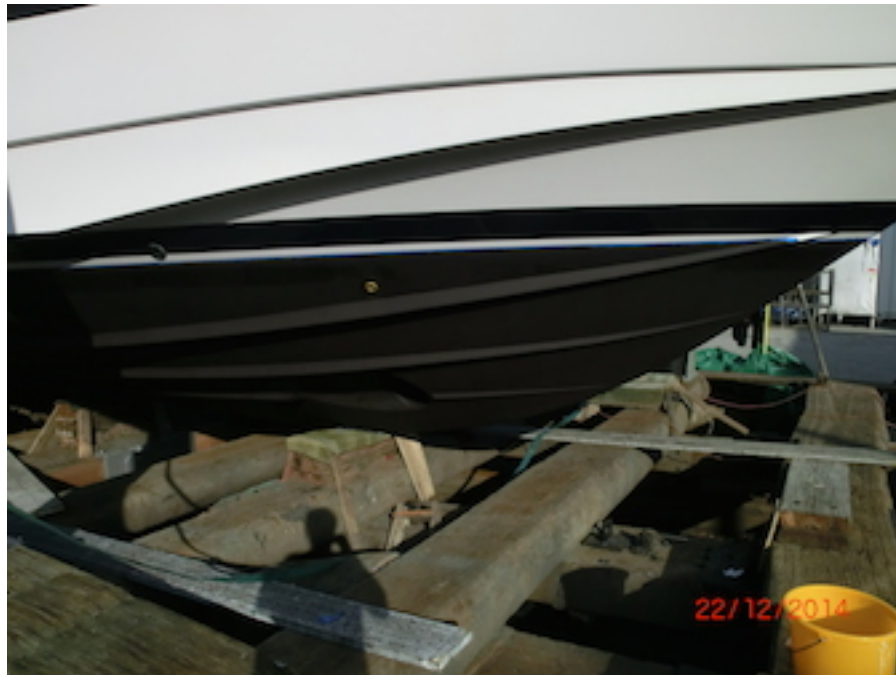
Photograph 7

View of starboard side bow.

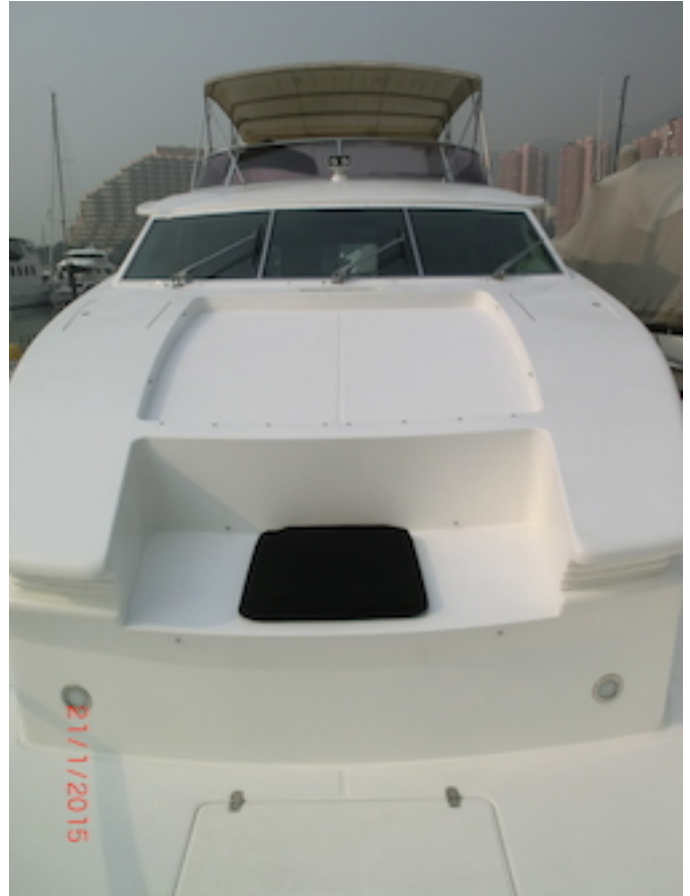
Photograph 11

View of superstructure.

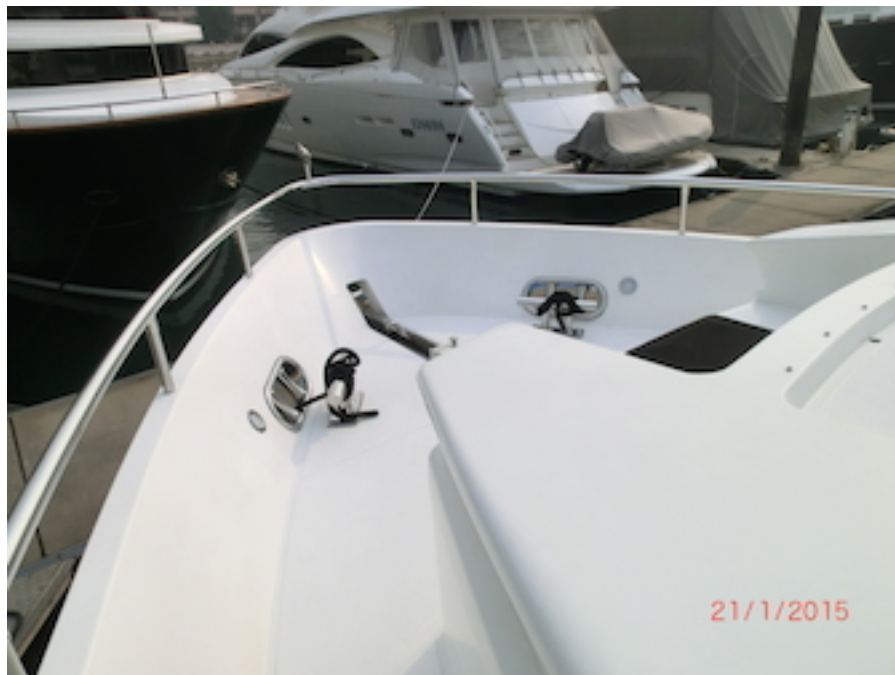
Photograph 12

View of foredeck.

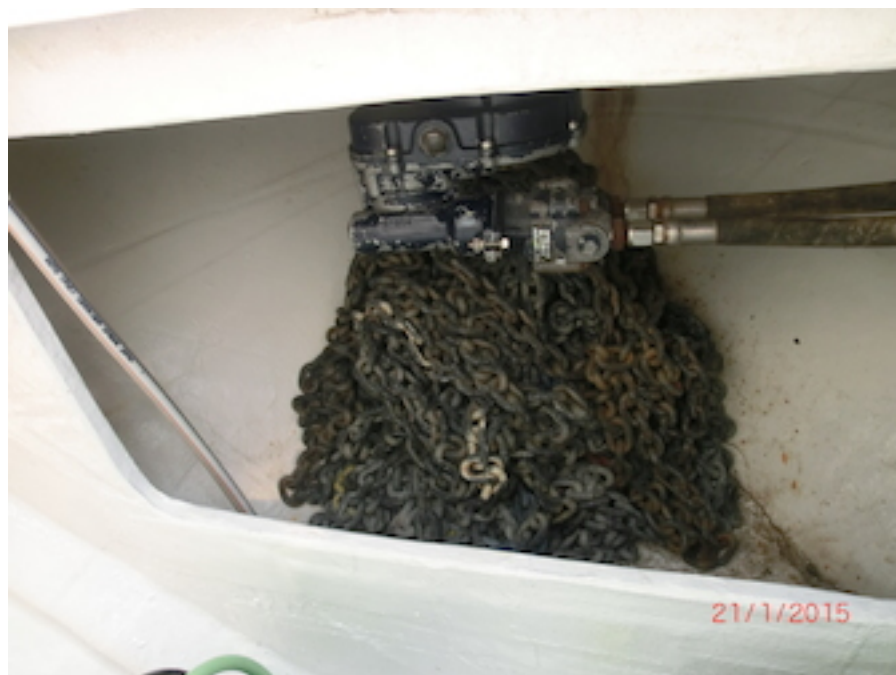
Photograph 14

View of chain locker & anchor chain.

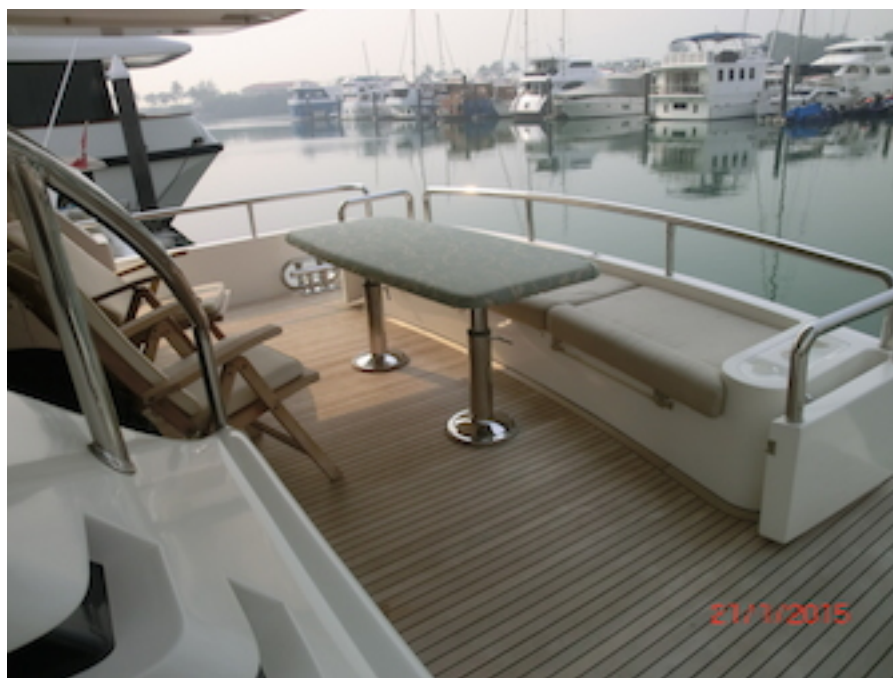
Photograph 15

View of after deck.

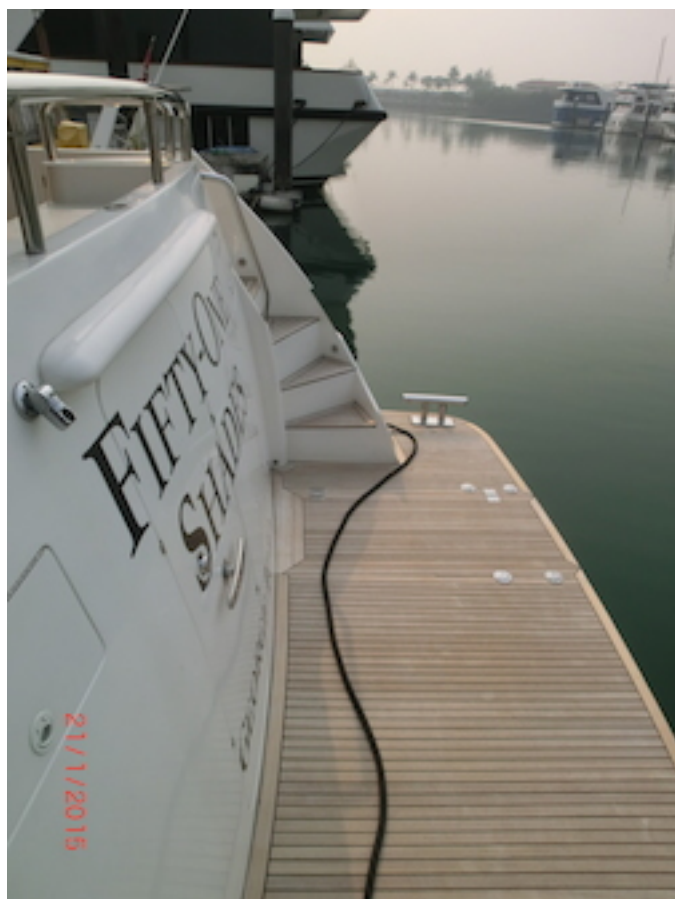
Photograph 16

TRANSOM DECK		
1.	Layout: (See Figure 1)	Small open platform across after end of the vessel fitted with transom shower. GRP door at port and starboard side aft of the after deck leads down to the transom deck.
2.	Deck Materials:	Longitudinally laid teak planking with dark caulking. Good.
3.	Swim Ladder:	Telescopic swim ladder stowed within the deck on the starboard side. Good.

View of transom deck.

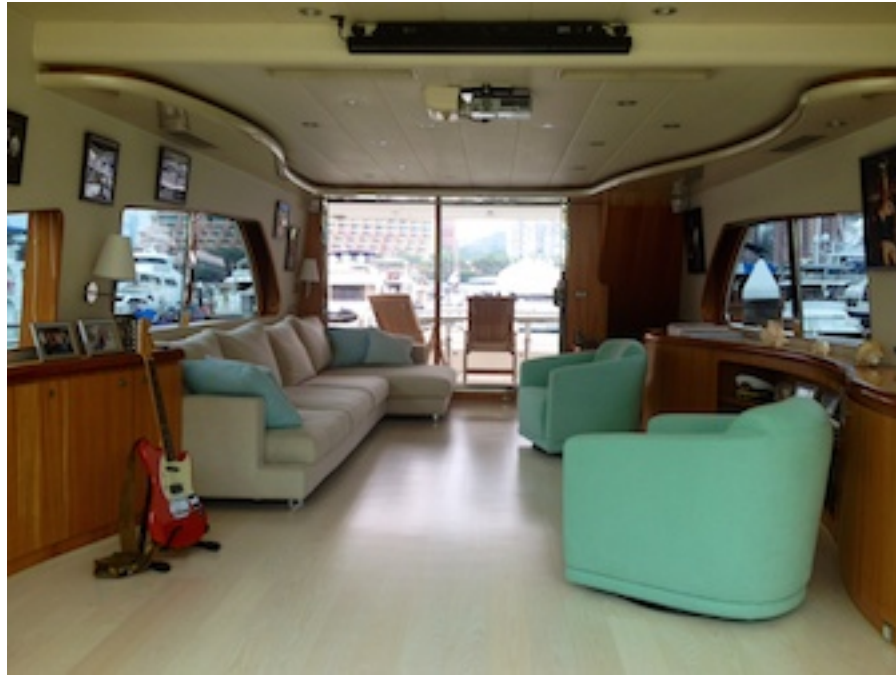
Photograph 17

View of main deck lounge from forward.

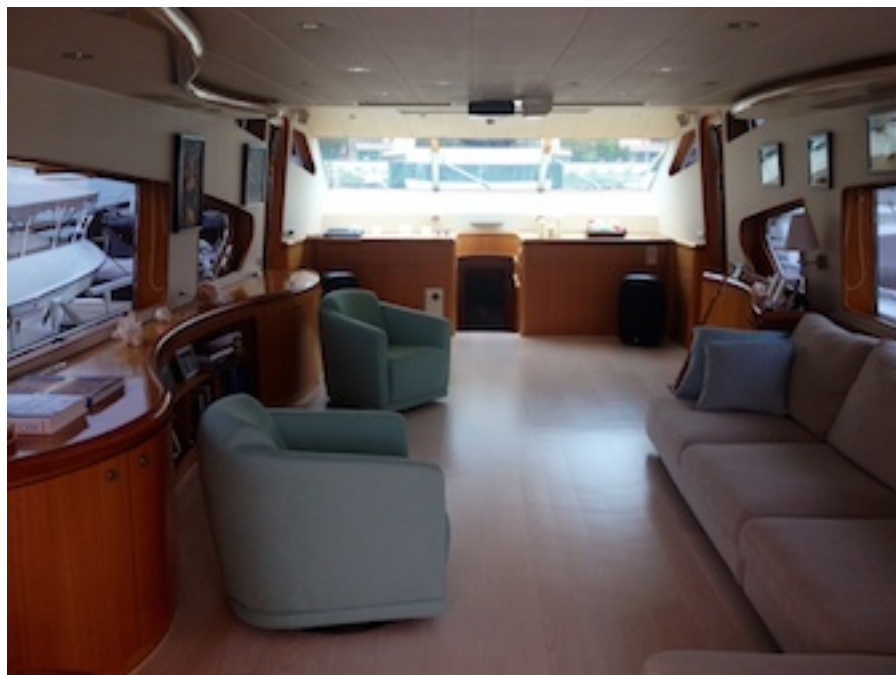
Photograph 18

View of main deck lounge from aft.

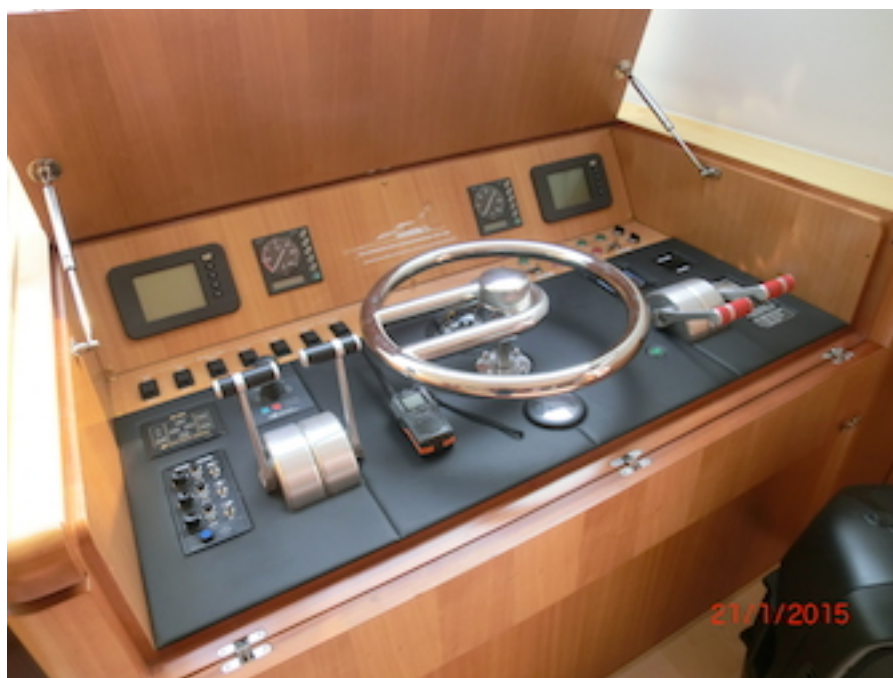
Photograph 19

View of main helm.

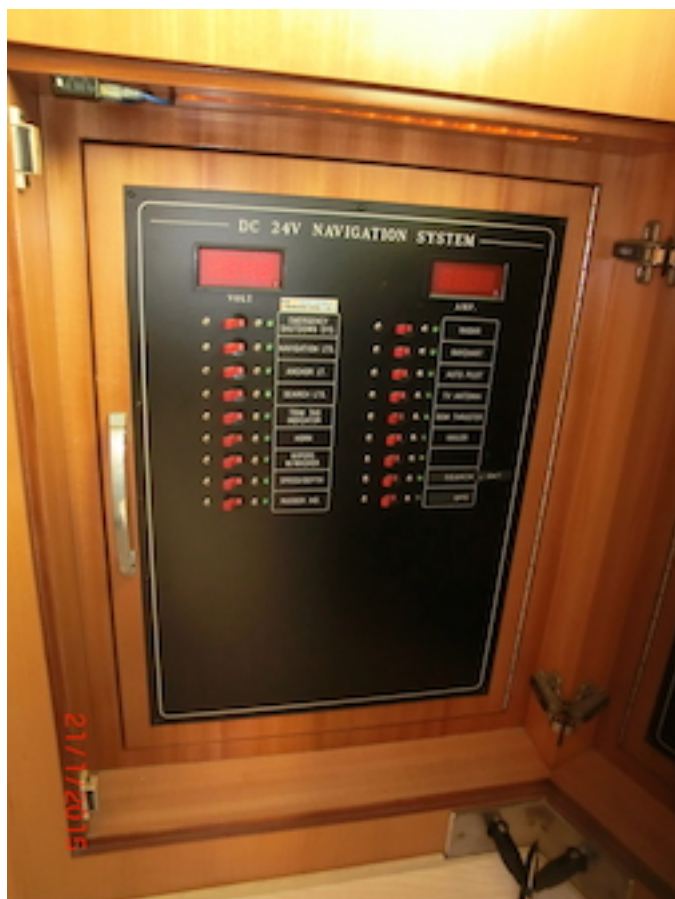
Photograph 20

View of navigation equipment switchboard.

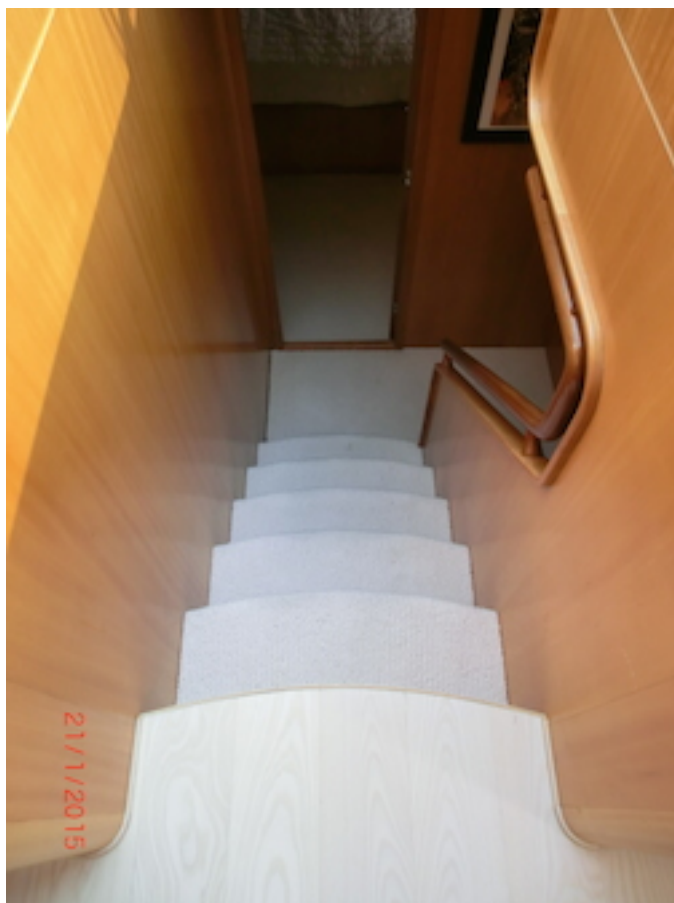
Photograph 21

View of staircase to lower deck.

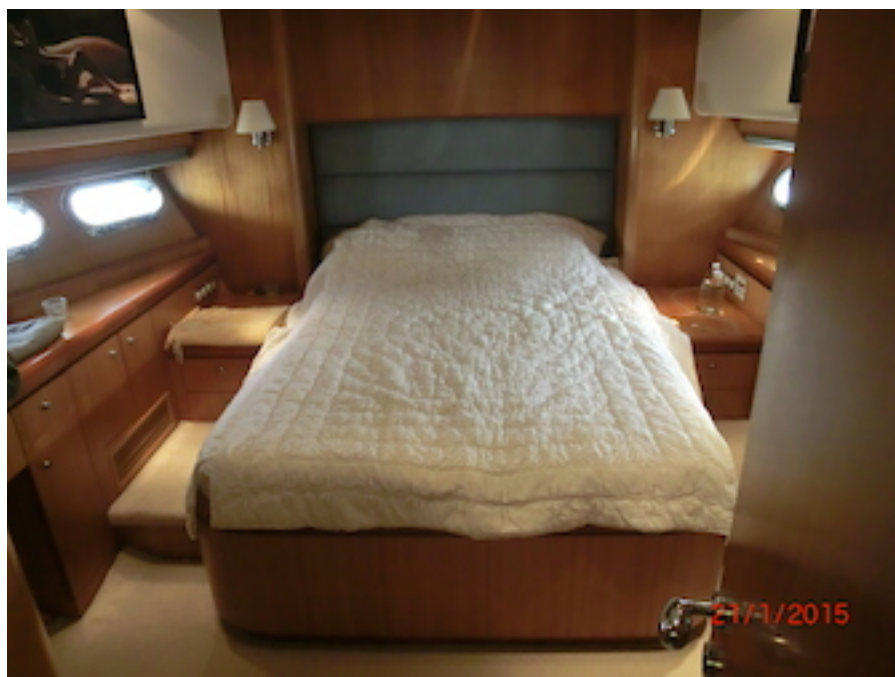
Photograph 22

View of master cabin.

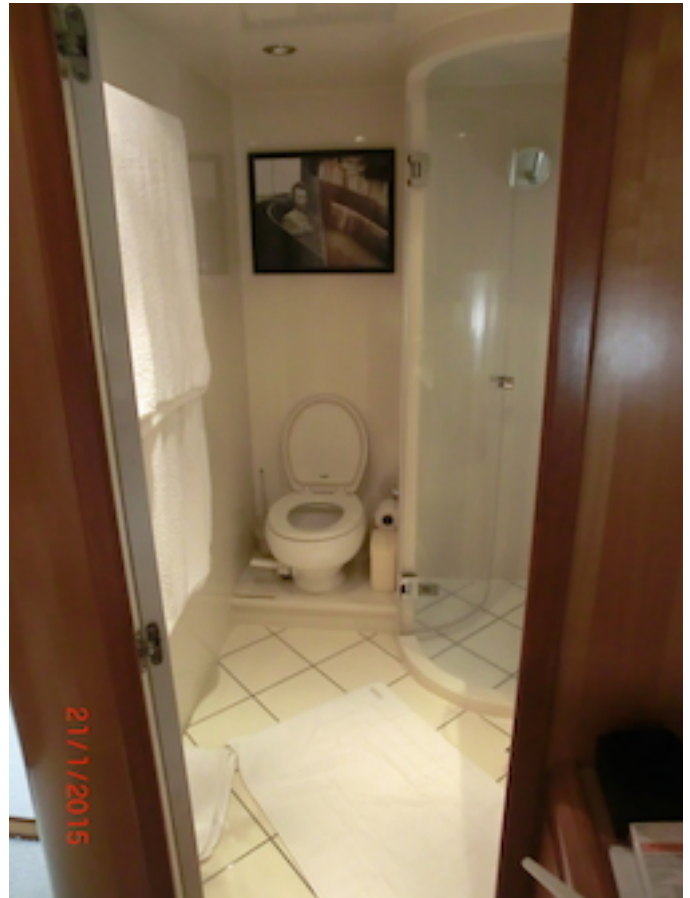
Photograph 23

View of master cabin en-suite bathroom.

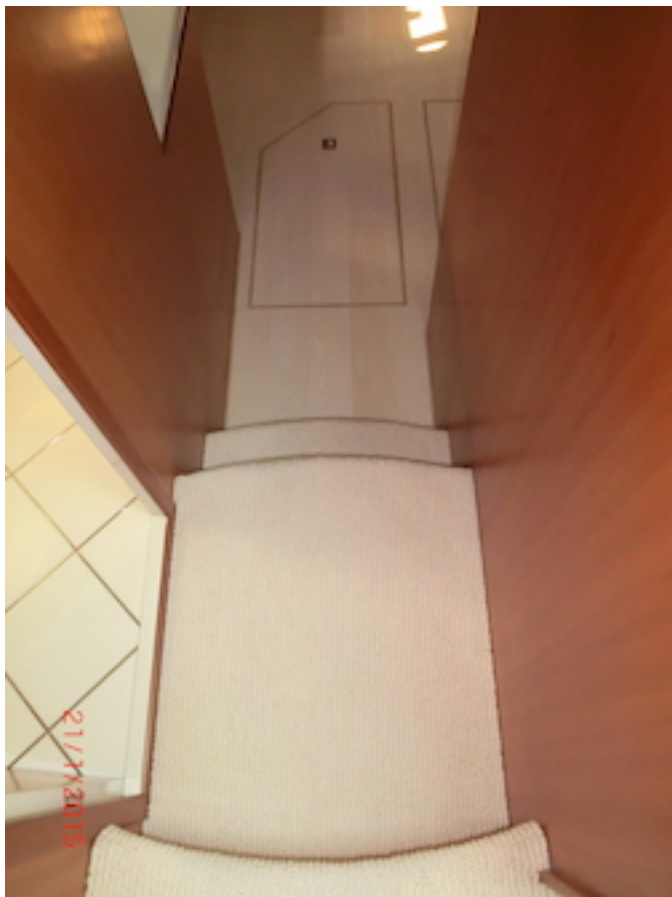
Photograph 24

View of steps galley.

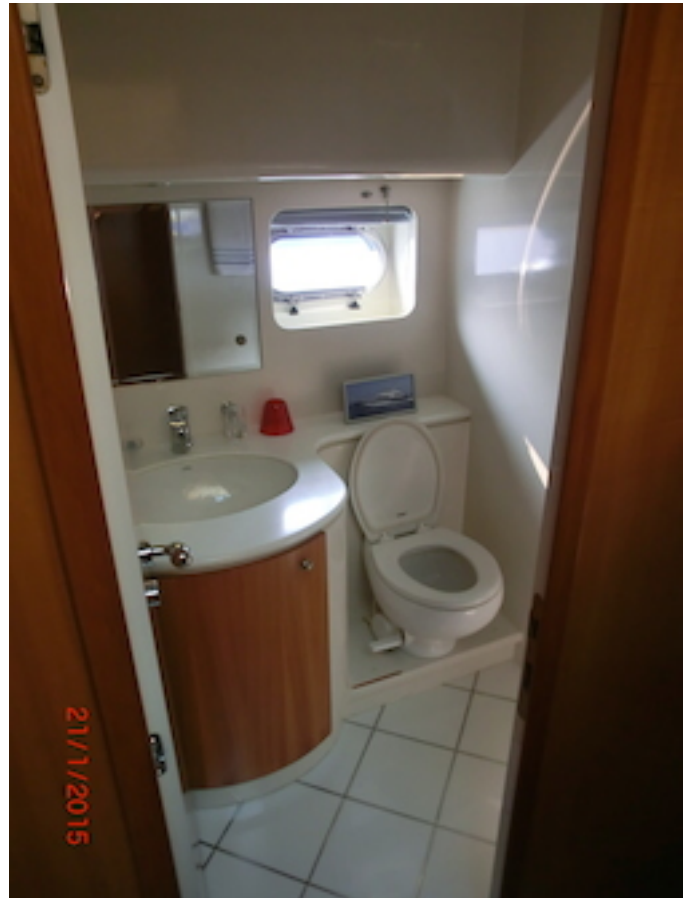
Photograph 25

View of lower deck guest bathroom.

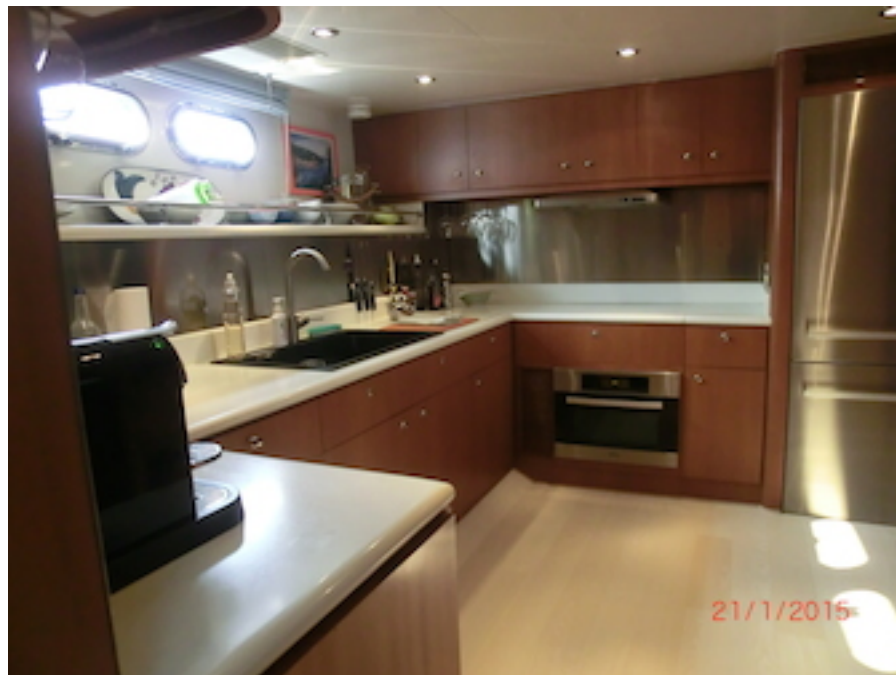
Photograph 26

View of galley.

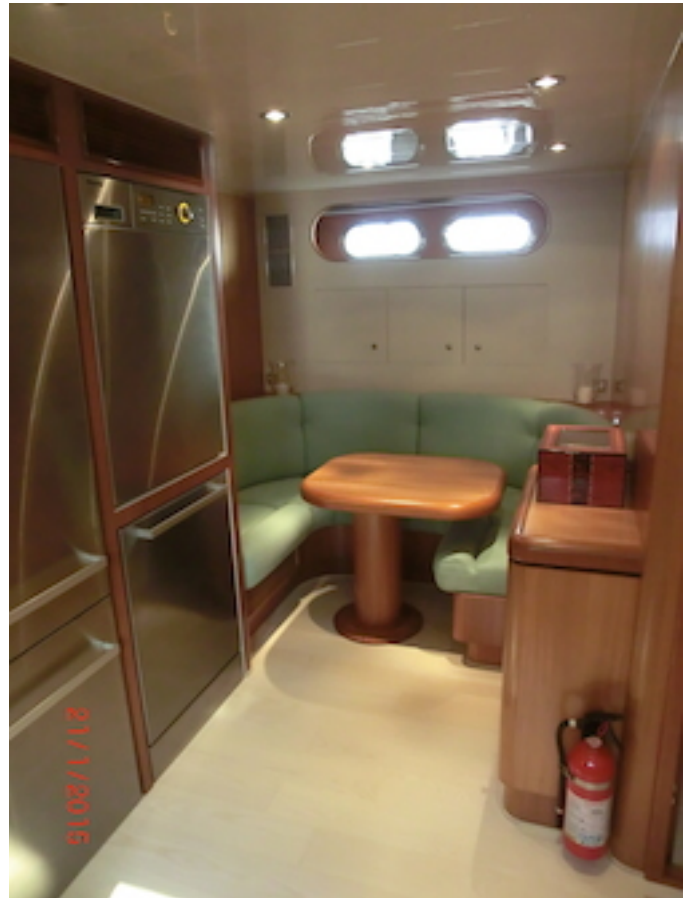
Photograph 27

View of dining area.

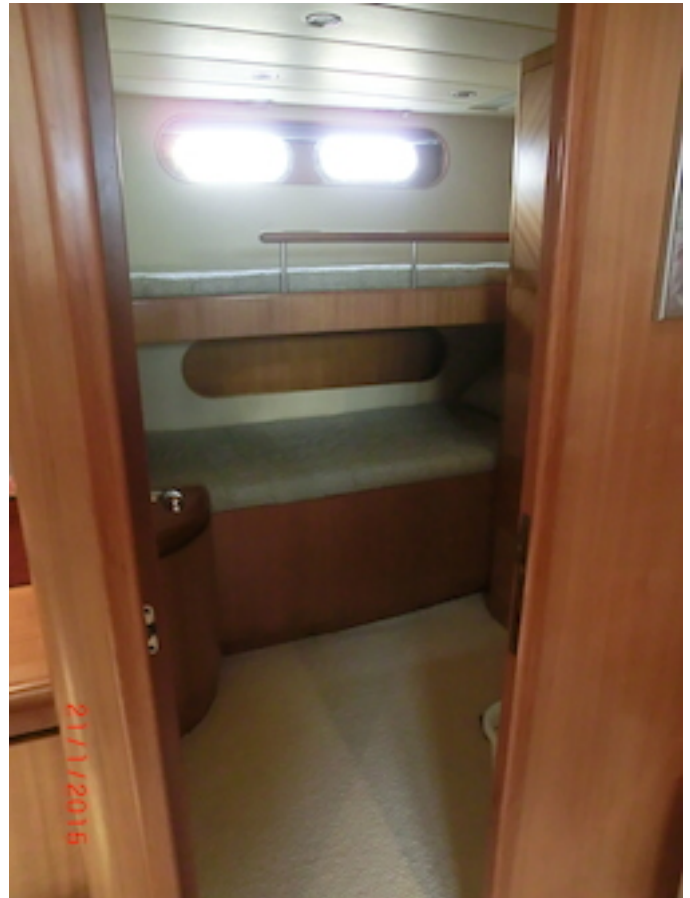
Photograph 29

View of guest cabin.

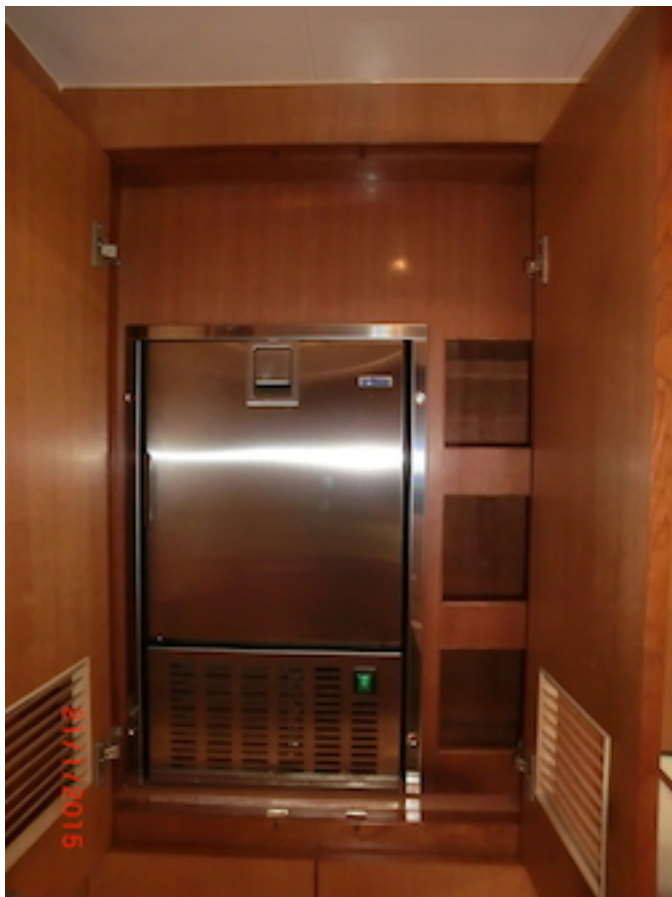
Photograph 30

View of icemaker.

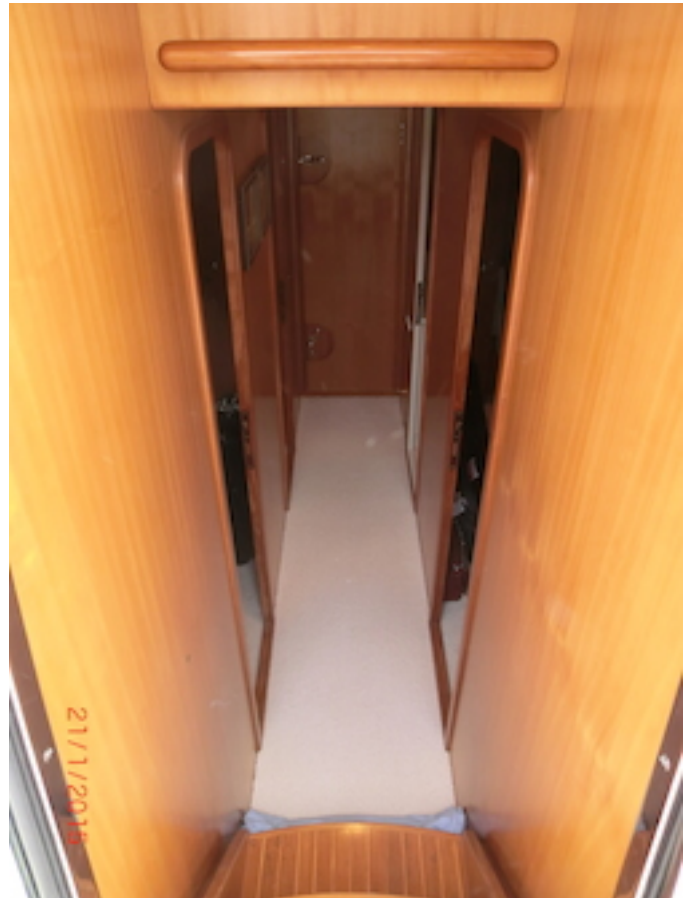
Photograph 31

View of guest quarter transom access.

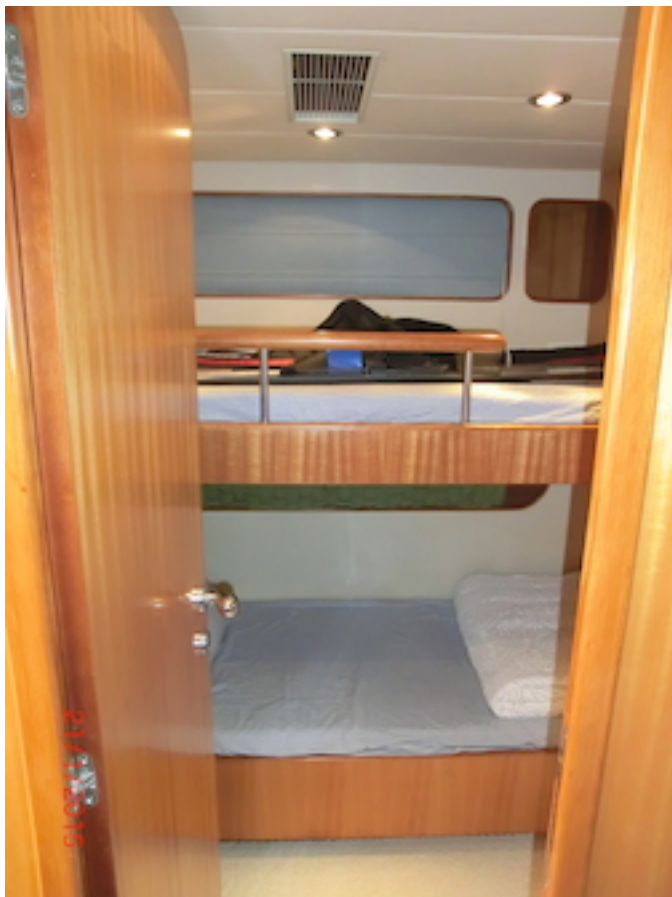
Photograph 32

View of twin bunks guest cabin.

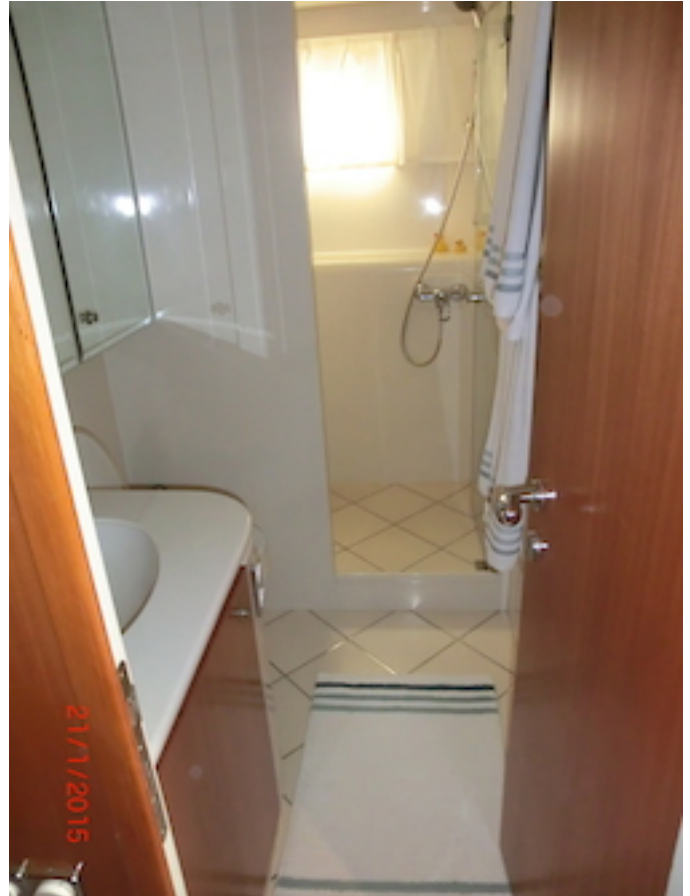
Photograph 33

View of guest bathroom.

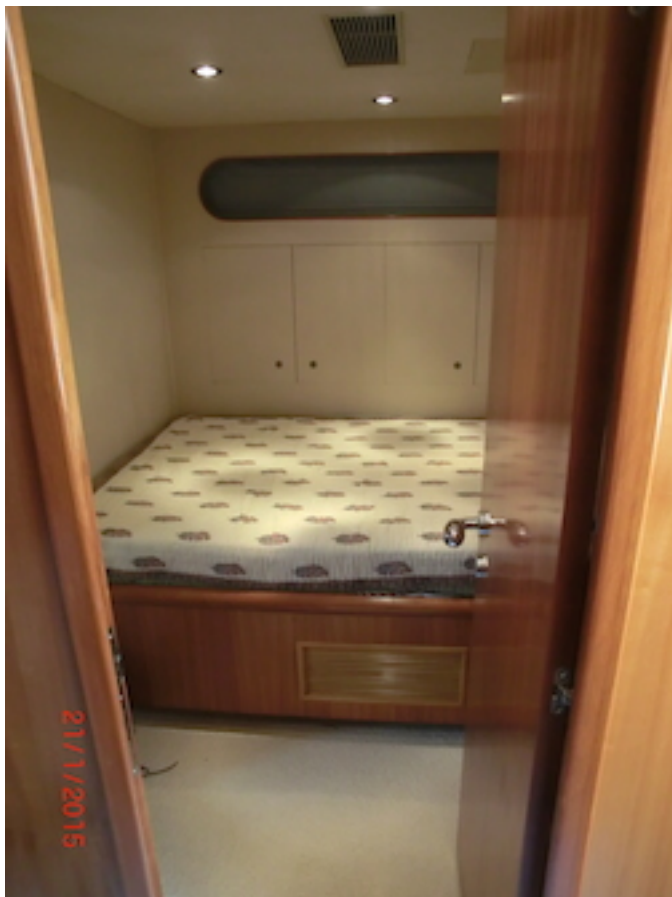
Photograph 34

View of double berth guest cabin.

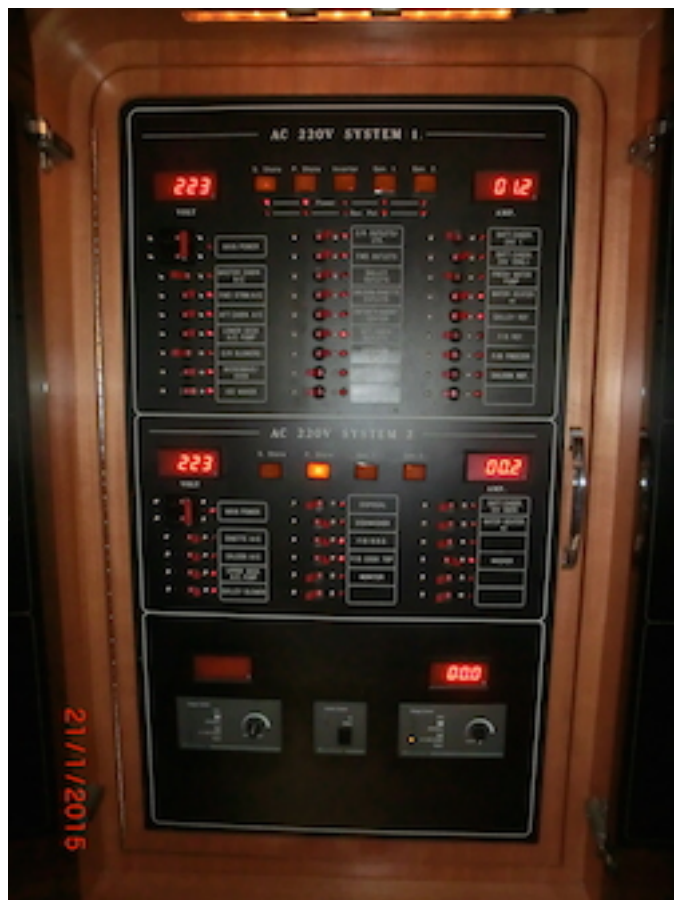
Photograph 35

View of 220V main switchboard.

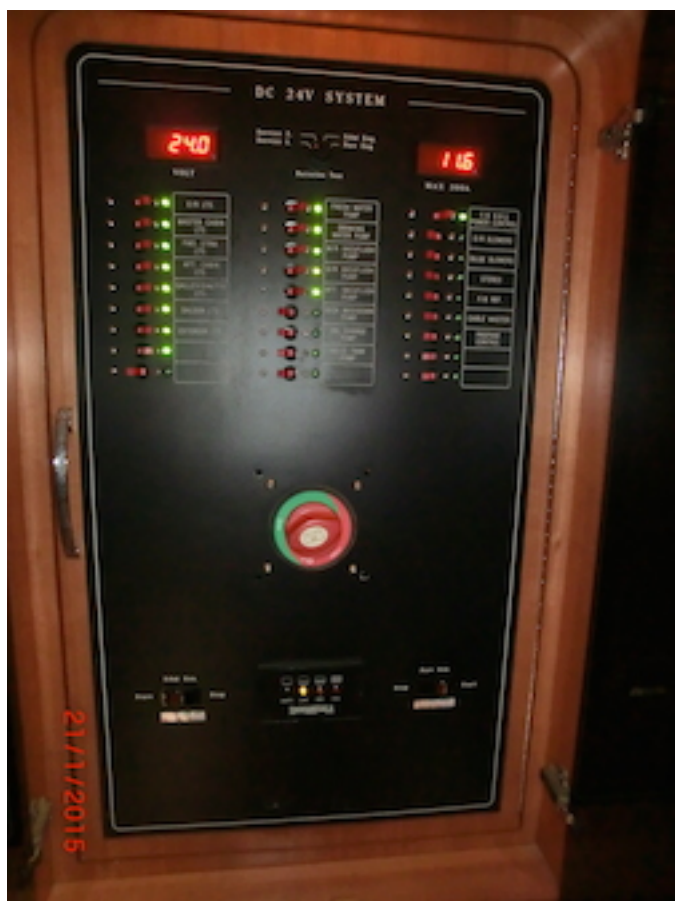
Photograph 36

View of 24V main switchboard.

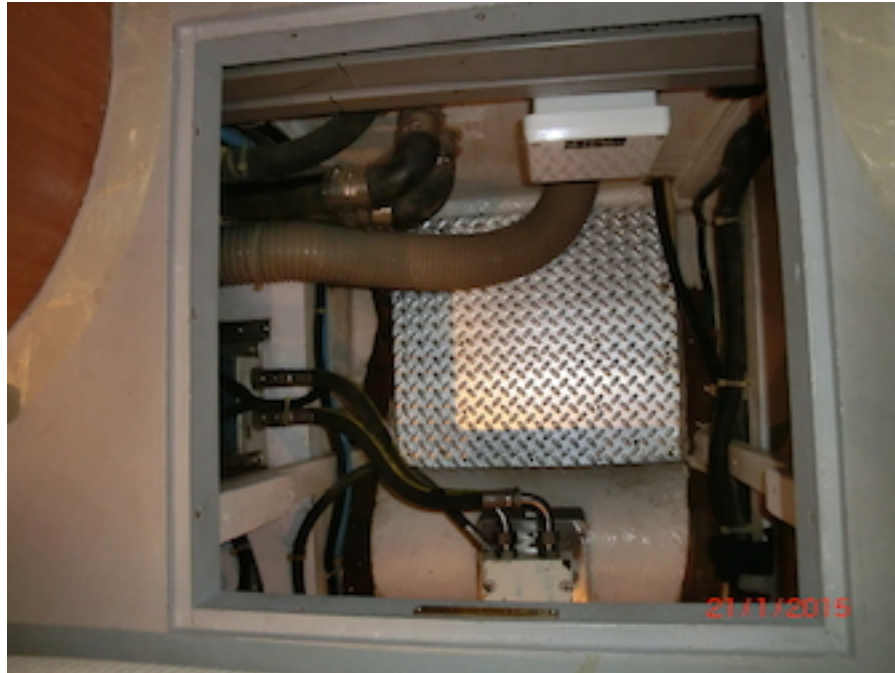
Photograph 37

View of forward bilge compartment.

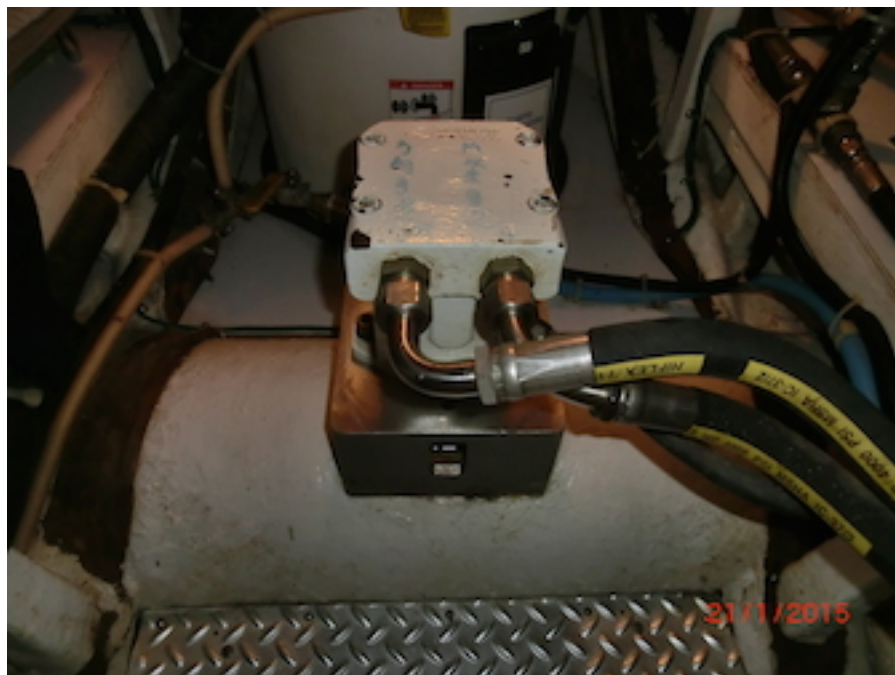
Photograph 38

View of hydraulic bow thruster motor.

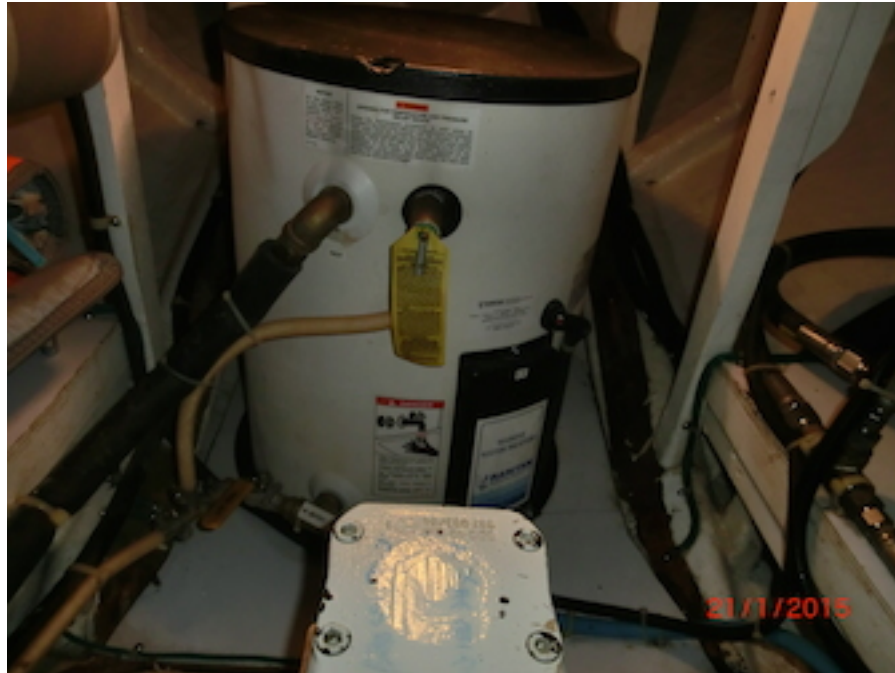
Photograph 39

View of marine type water heater.

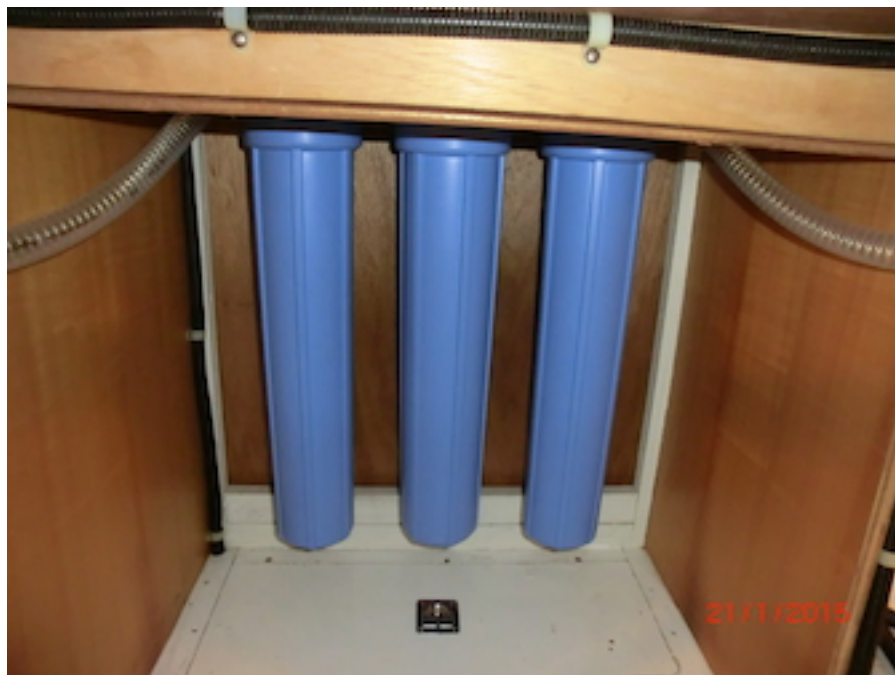
Photograph 40

View of freshwater filtration system.

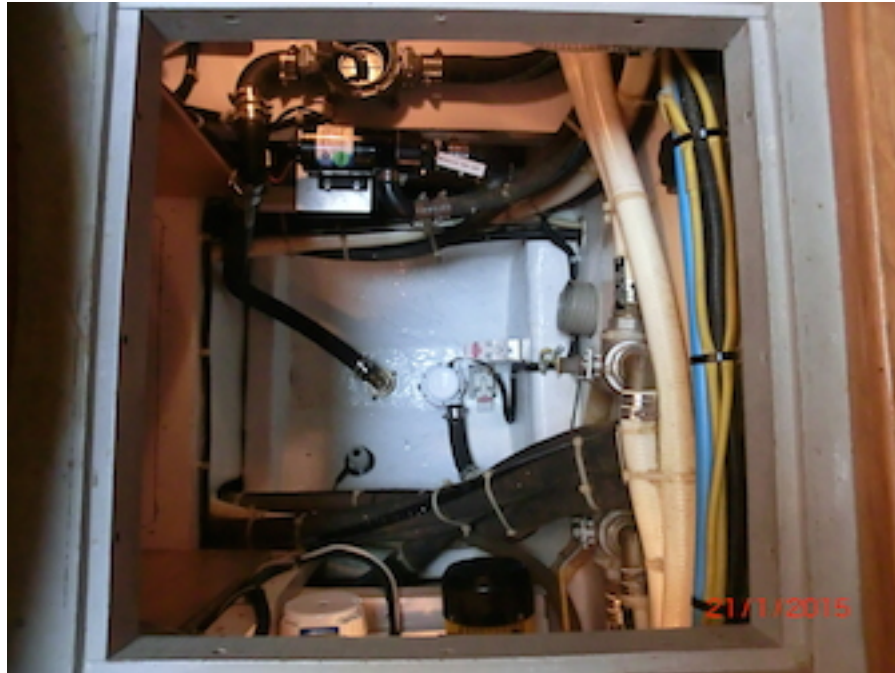
Photograph 41

View of forward bilge compartment.

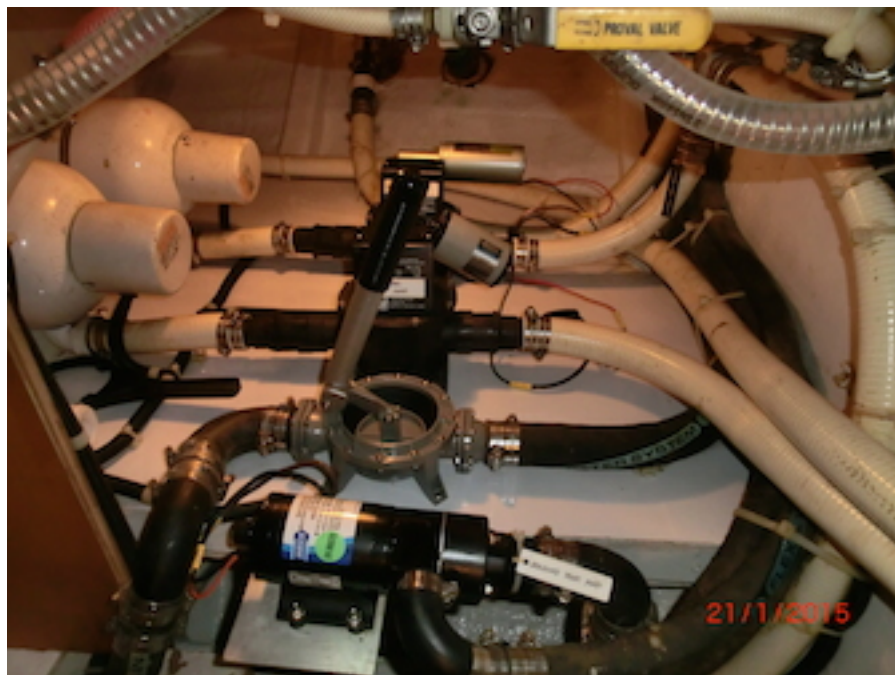
Photograph 42

View of vacuum toilet motors.

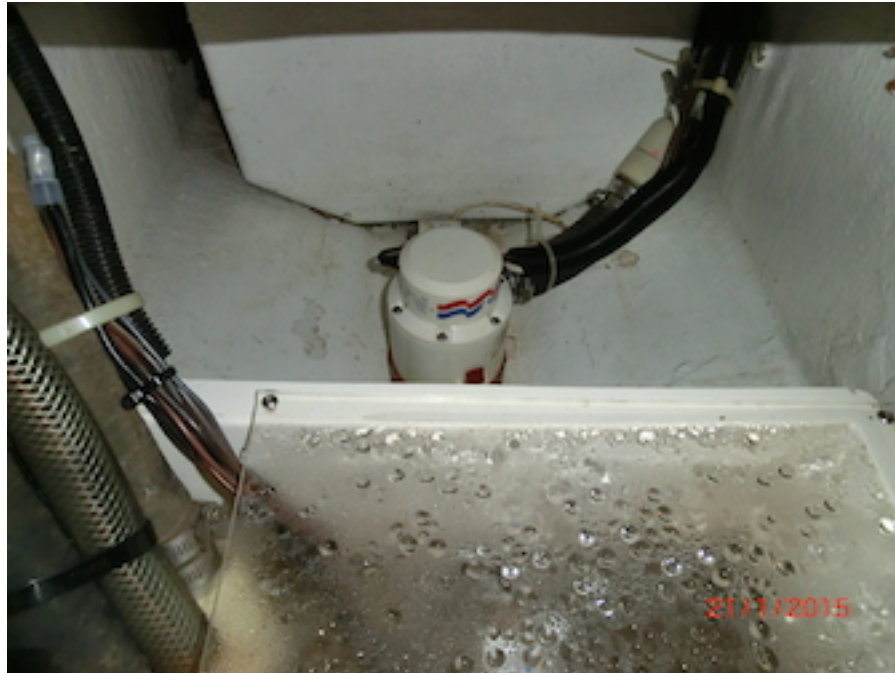
Photograph 43

View of forward bilge pump.

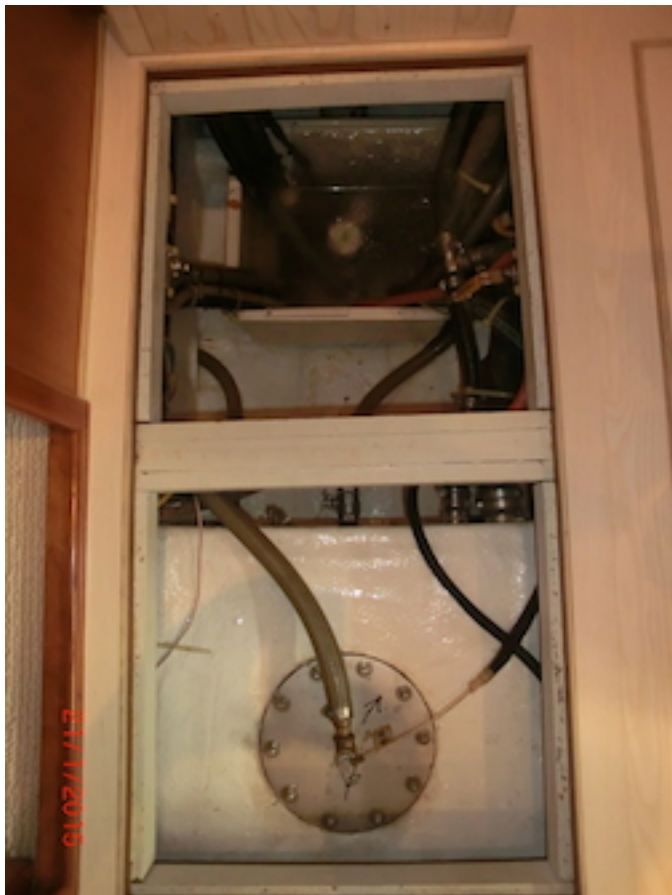
Photograph 44

View of aft bilge compartment.

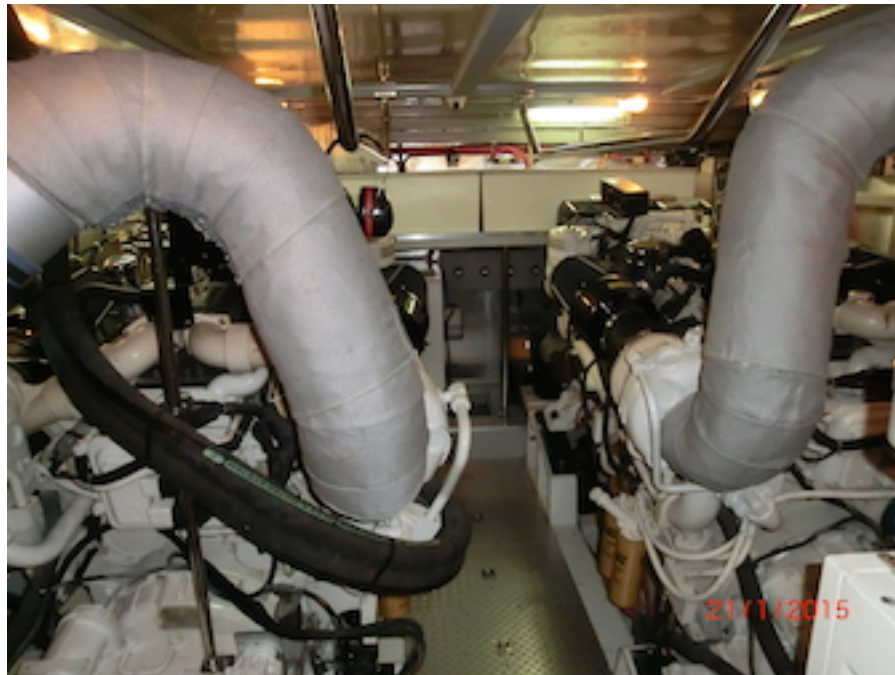
Photograph 45

View of engine room.
