51 SHADES

Valuation & Condition Survey
Hong Kong
16 December 2014 & 21 January 2015

51 SHADES is a GRP, twin screw, motor yacht.

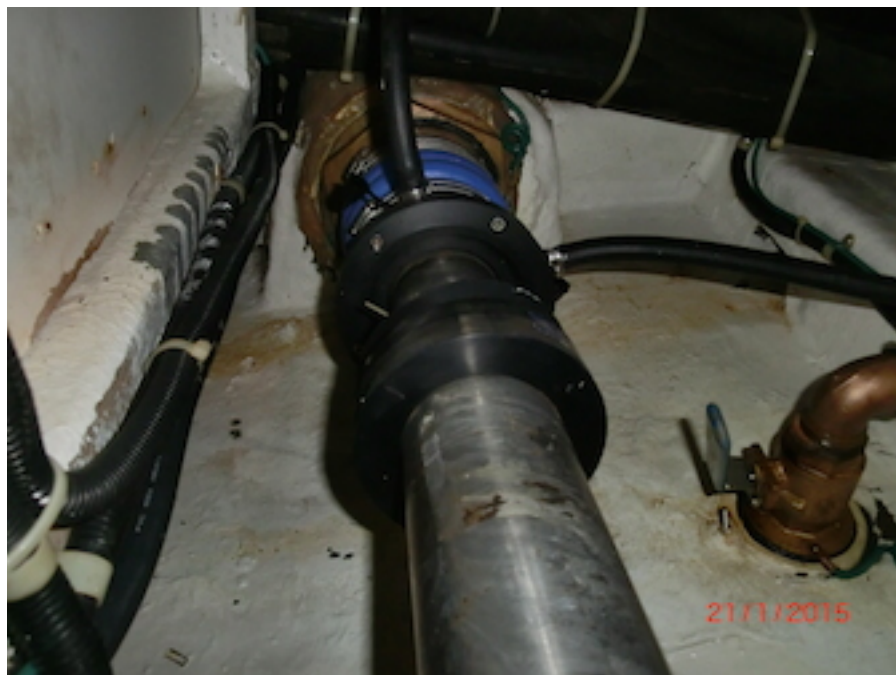
Photograph 48

View of port stern gland.

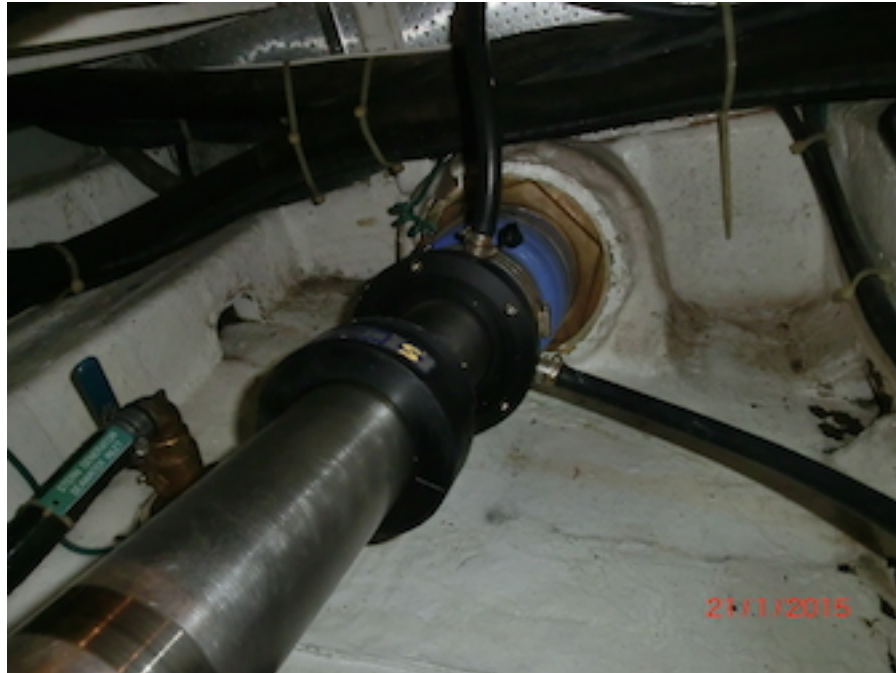
Photograph 49

View of starboard stern gland.
